Correlation of Professional Performance to Acceptable IAQ in Critical Care Medical Facilities

H.W. Holder¹, K.V. Easterwood, Jr.², D.E. Johnson³,
J.W. Sealy⁴, M.D.Larranaga⁵ and D.C. Straus⁶

3. Case studies

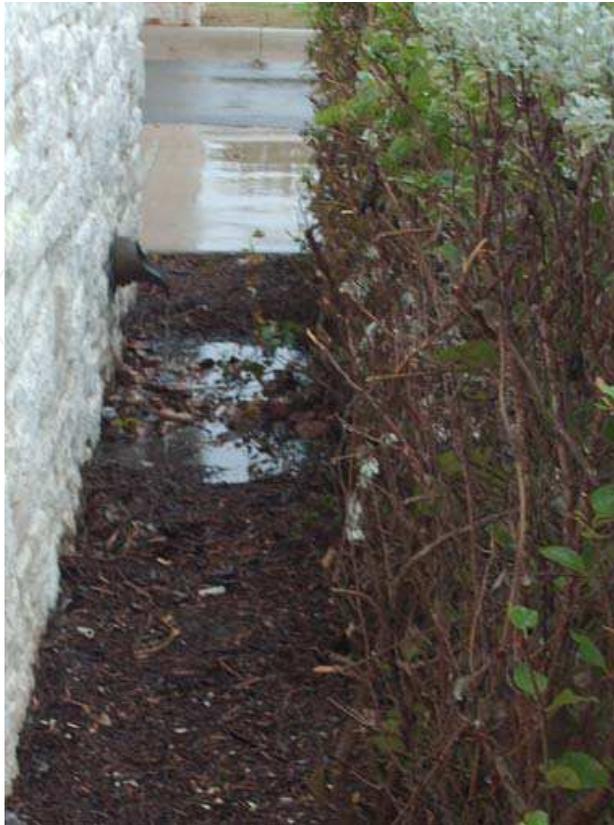
This single story surgery center was constructed in 2004. It was 19,000 square feet and constructed under a design/build delivery system.⁵ Its exterior was composed of applied stone veneer and an Exterior Finish Insulation System (EFIS). The hospital staff noticed mold growth, wild swings in temperature, and wet indoor environment almost from the day they occupied the building. An investigation ensued and determined that defects discovered associated with the shell of the building, or envelope, was a major contributor, along with the HVAC, to the difficulties they were encountering. Site drainage violated code and held water against the building. It is fundamental to the proper placement of a building to locate it on the site both vertically and horizontally. The horizontal aspect of the placement is guided by local zoning codes. Vertical placement is guided by common sense, water should drain away from a building and thus, downhill. Building codes have language to ensure that the common sense approach is met. For example the building code reads: "The ground immediately adjacent to the foundation shall be sloped away from the building at a slope of not less than one unit vertical in 20 units horizontal (5-percent slope) for a minimum distance of 10 feet (3048 mm) measured perpendicular to the face of the wall or an approved alternate method of diverting water away from the foundation shall be used." (International Building Code [IBC] Chapter 18: Soils and Foundation, 1803.3 Site Grading, 2000).

Fig. 1. Site drainage violated code and, held water against the building.

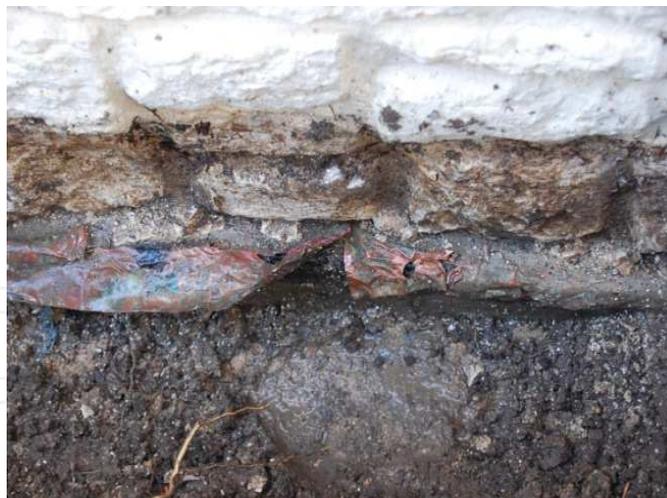
When combined with the fact that water stands against the building, the base flashing not only did not allow water to drain it instead reversed the flow of water such that outside water entered the building. The end result was mold growth along the entire perimeter of the building.

Fig. 2. The copper-coated base flashing at the applied masonry veneer wall terminated below grade and therefore did not allow for the water to drain.

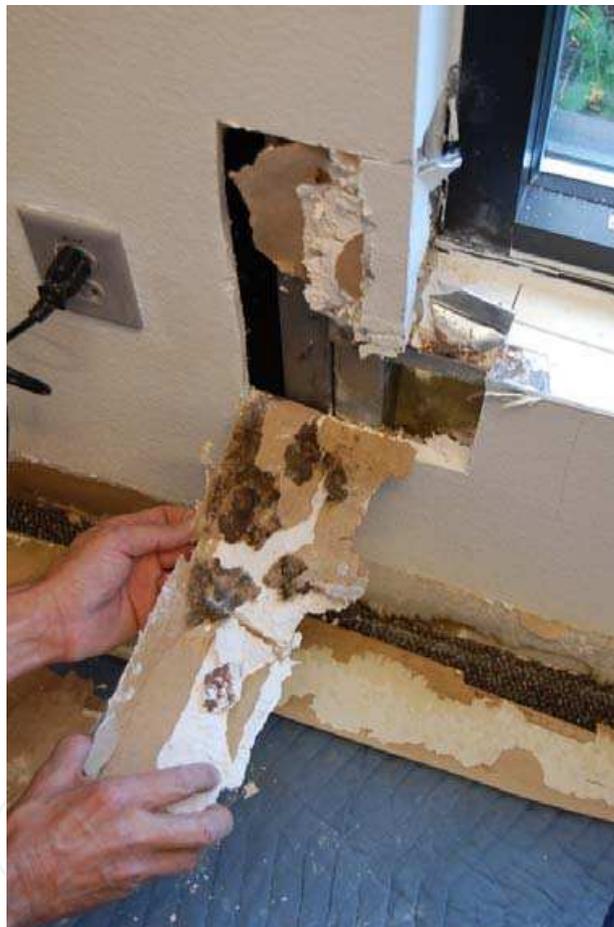
Fig. 3. Mold caused by moisture in the wall cavity.

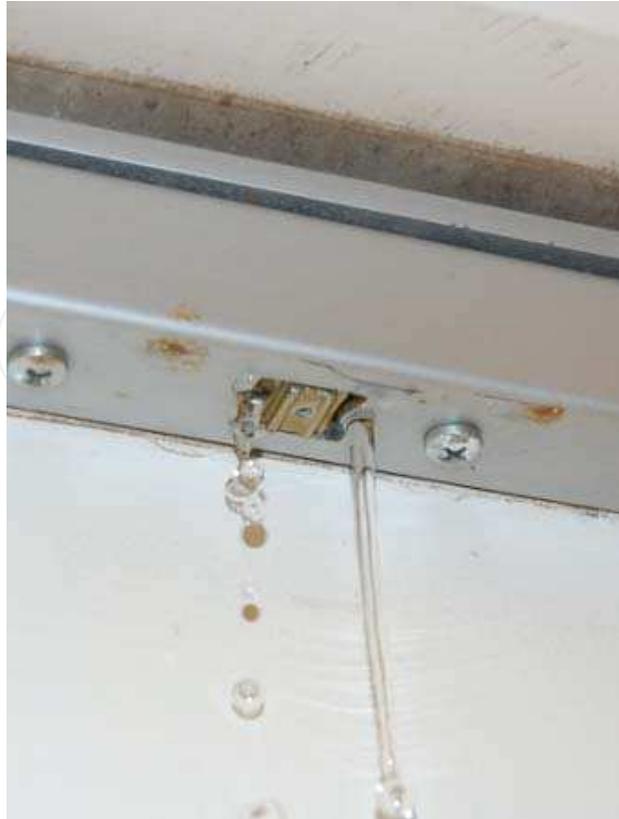
Doors, windows, and louvers all penetrate the walls, thus flashings are also used to divert water to the exterior of a building. Codes (IBC Section 1405.3; Flashing., 2003) and manufacturer's details leave no doubt that the flashing of openings is a requirement, and that information as to materials and methods are readily available. The consequence of ignorance or neglect is water pouring into the building.

Fig. 4. Water entering the building because of inadequate flashing.

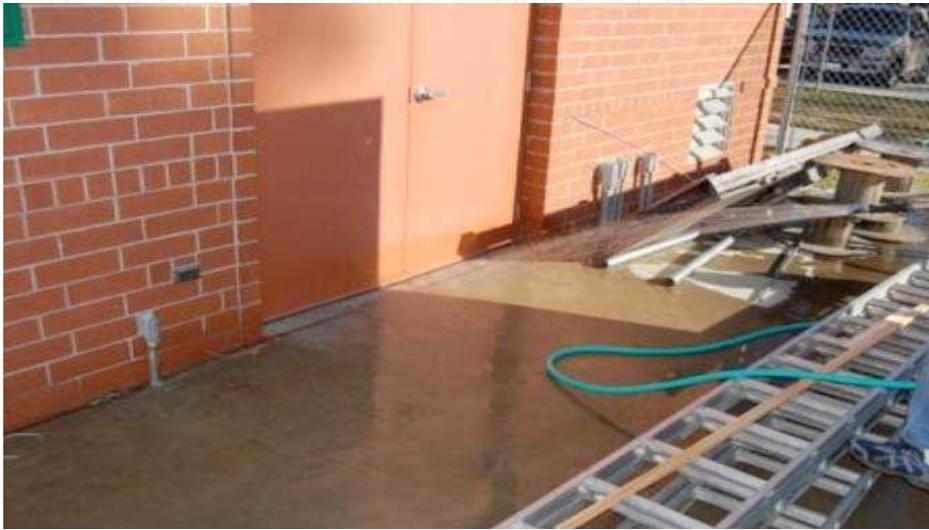
Fig. 6. Site drainage violated code and held water against the building.

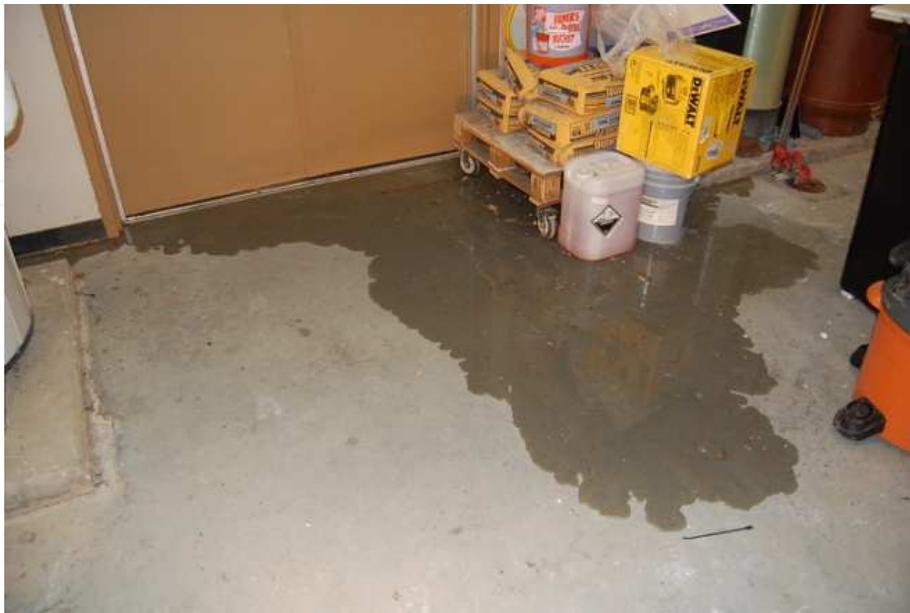
As in CS 1, common sense and conformance to building codes were not observed at this project. For example, fig. 7 showed water standing at a door that subsequently entered the building.

Fig. 7. A flawed detail at the base of the building compounded the threat to the building posed by standing water.

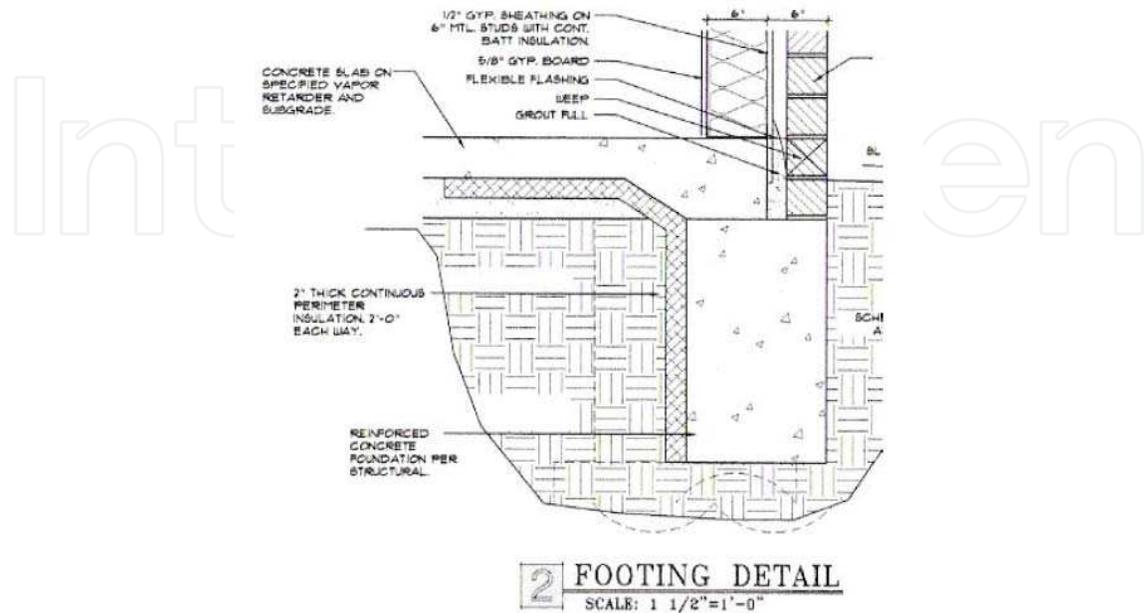
Fig. 8. The architect's detail correctly shows the acceptable method of installing base flashing when the masonry terminates into grade.

However, he failed to follow manufacturer's recommendations and buried the exterior sheathing into the grout fill. Inattention to detail by both architect, who failed to refer to the manufacturer's guidelines, and contractor, who failed to notice the defect, led to the unacceptable condition. As a result of these errors water stands within the wall cavity posing a continuing threat to building materials.

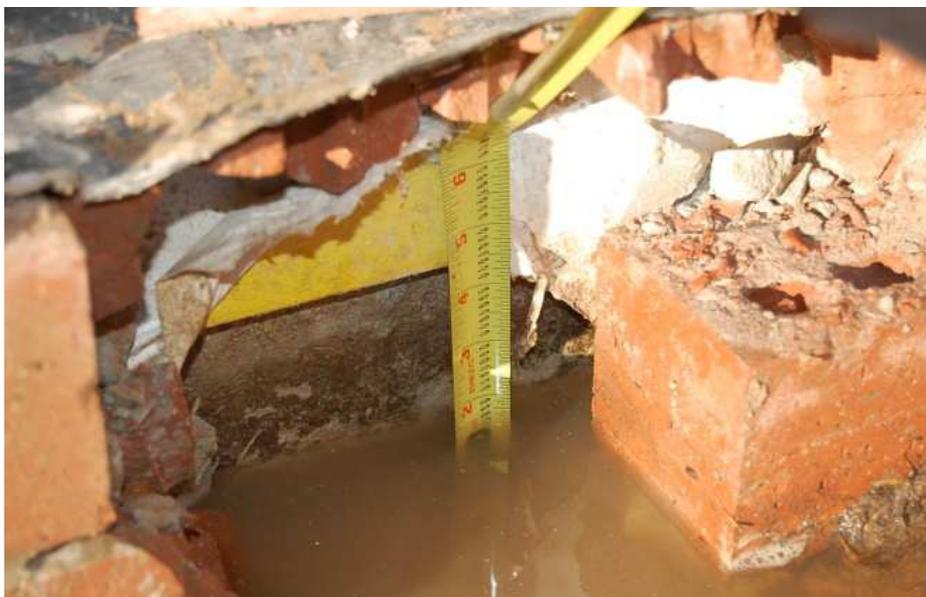
Fig. 9. Water standing inside the wall cavity.

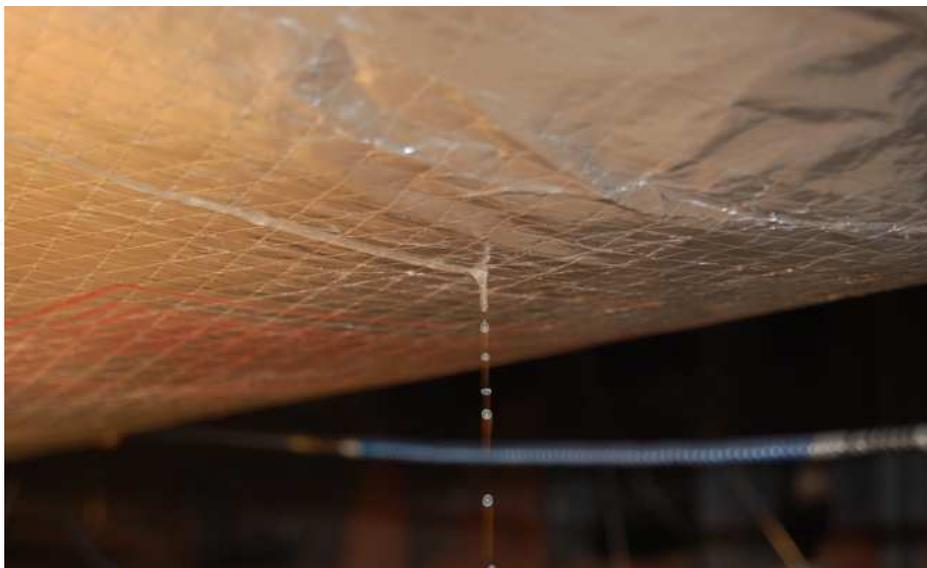
Fig. 10. Water running out of insulation.

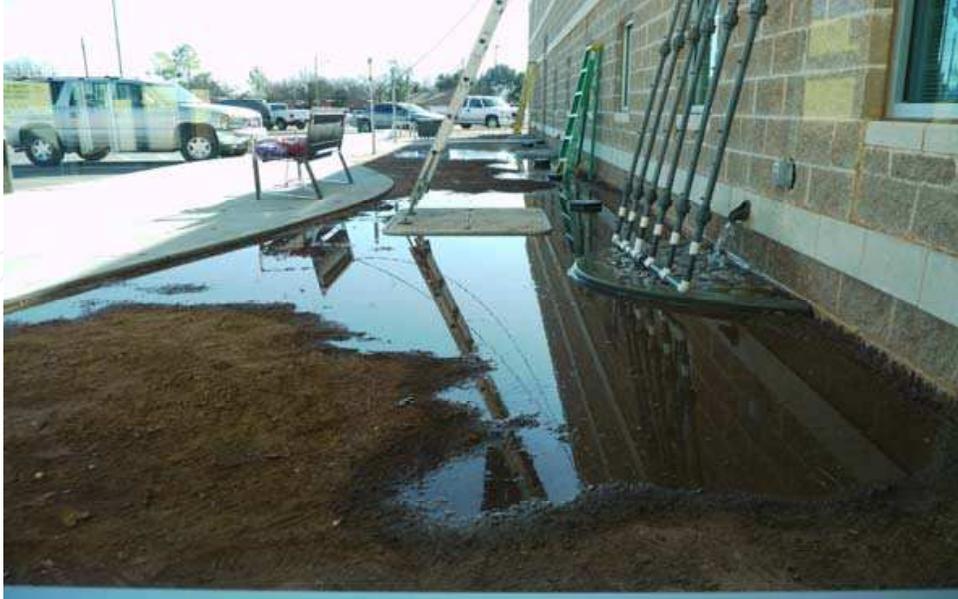
Fig. 11. Improper site grading.

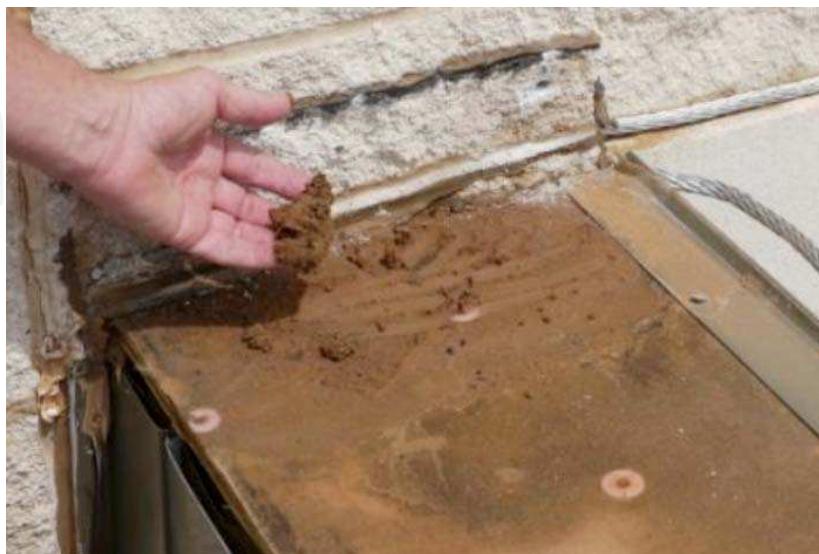
Figures 13, 14 and 15 show the progression of dust (particulate) from the parapet, into the exterior wall via mislapped flashing and finally into the ceiling space of the hospital. In agricultural settings dust is especially problematic in a critical care hospital. In a 2009 published study dust was found to contain endotoxins, allergens, microbial pathogens, bacterial toxins, fungal spores, and mycotoxins that can cause adverse human reactions. (Purdy & Straus 2009)

Fig. 13. Infiltration of dirt and moisture under parapet cap.

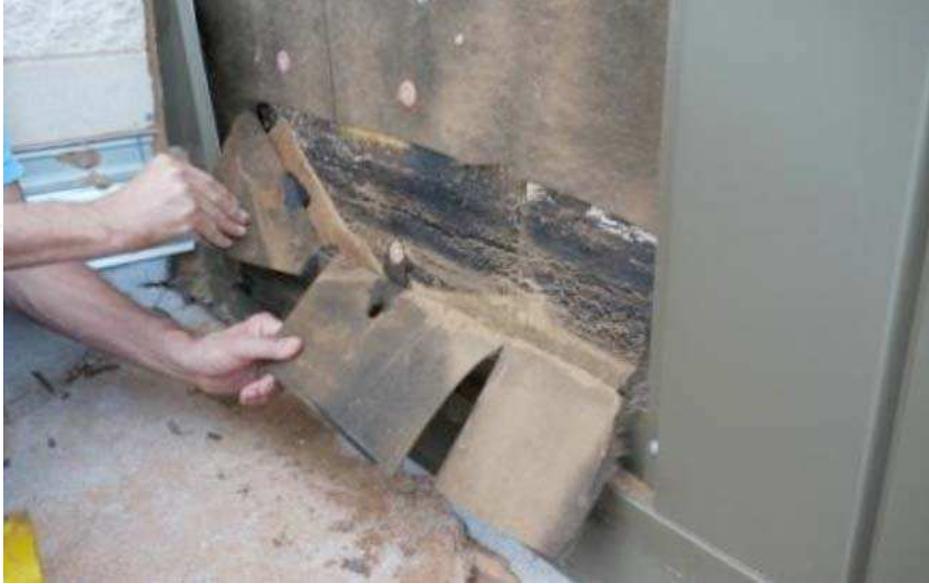
Fig. 14. Infiltration of dirt and moisture under parapet wall.

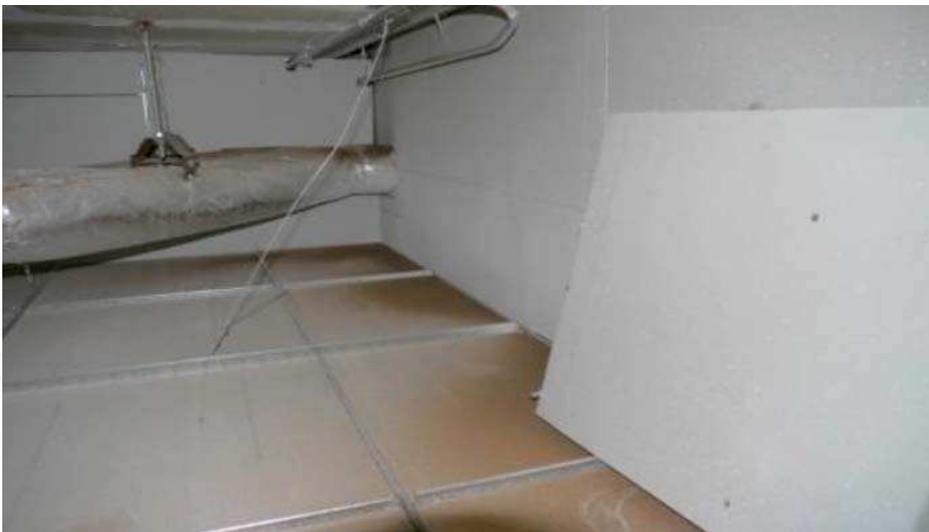
Fig. 15. Infiltration of dirt into the attic space above lay in ceiling.

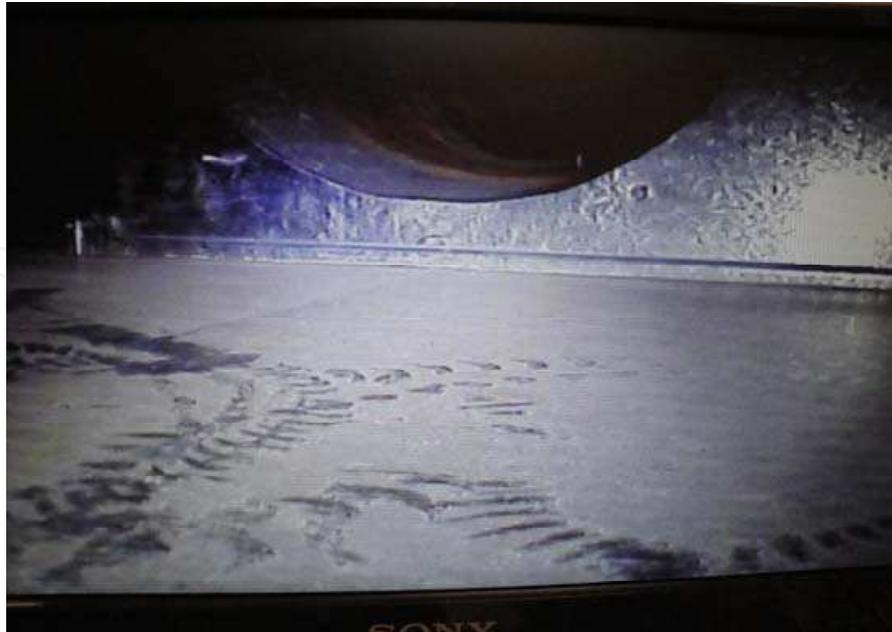
The building was under construction for a long time and the duct work was never protected during construction. The duct work was not cleaned before operating the equipment. Dust in the ductwork was deep enough to leave ruts when a robot was used to photograph the ductwork to an operating room.

Fig. 16. Tracks of robotic camera in the dust of the HVAC ductwork.

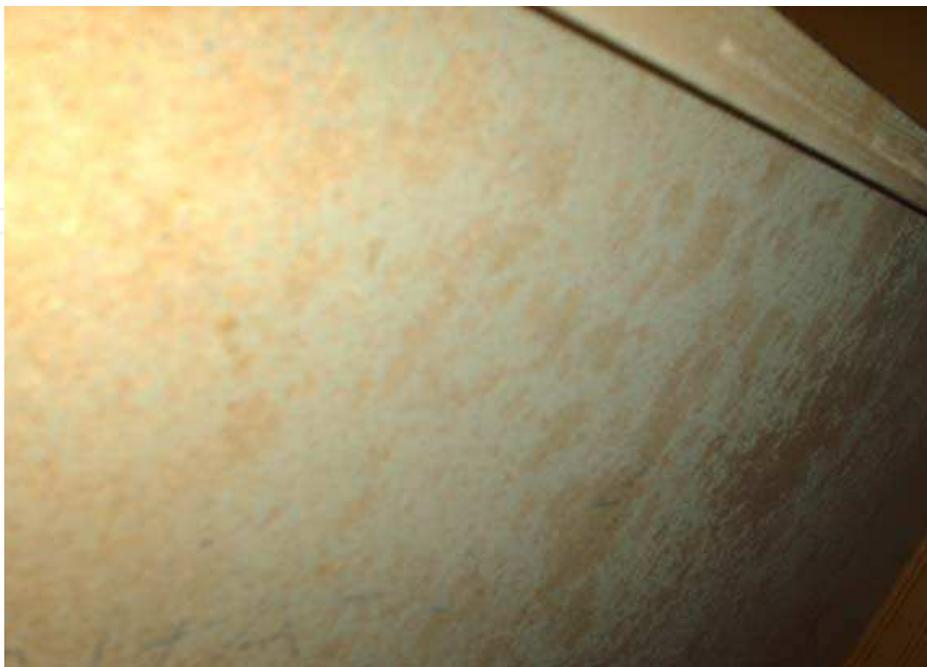
Fig. 17. Mold under a nurses desk.
