Assessment of Safety Standards of Magnetic Resonance Imaging at the Korle Bu Teaching Hospital (KBTH) in Accra, Ghana

Samuel Opoku, William Antwi and
Stephanie Ruby Sarblah

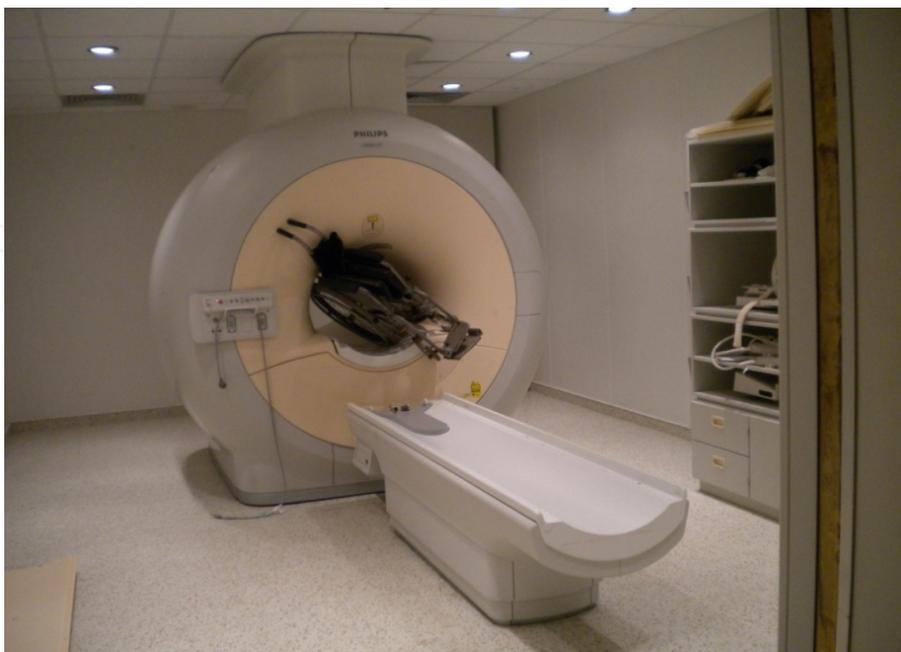
Figure 2.

A photograph of the wheelchair that got trapped in the gantry of the MRI Scanner on the 12th of May, 2010 at the Korle Bu Teaching Hospital, Accra. Ghana
