# Investigation of High Energy Arcing Fault Events in Nuclear Power Plants

Heinz Peter Berg<sup>1</sup> and Marina Röwekamp<sup>2</sup>

## **Nuclear Power - Operation, Safety and Environment**

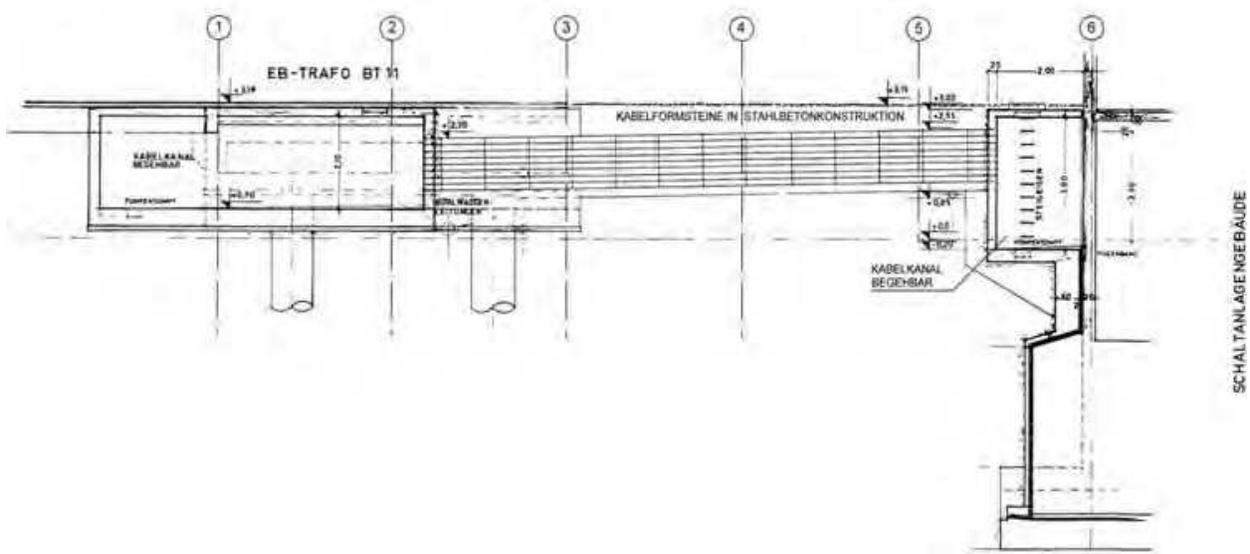
Due to the conditions in the ground, cables were partly imbedded in so-called 'cable cylinder blocks' manufactured from concrete (see Figure 2).

Fig. 2. Cross section of the cable tray inside the cable cylinder blocks inside ground between the buildings

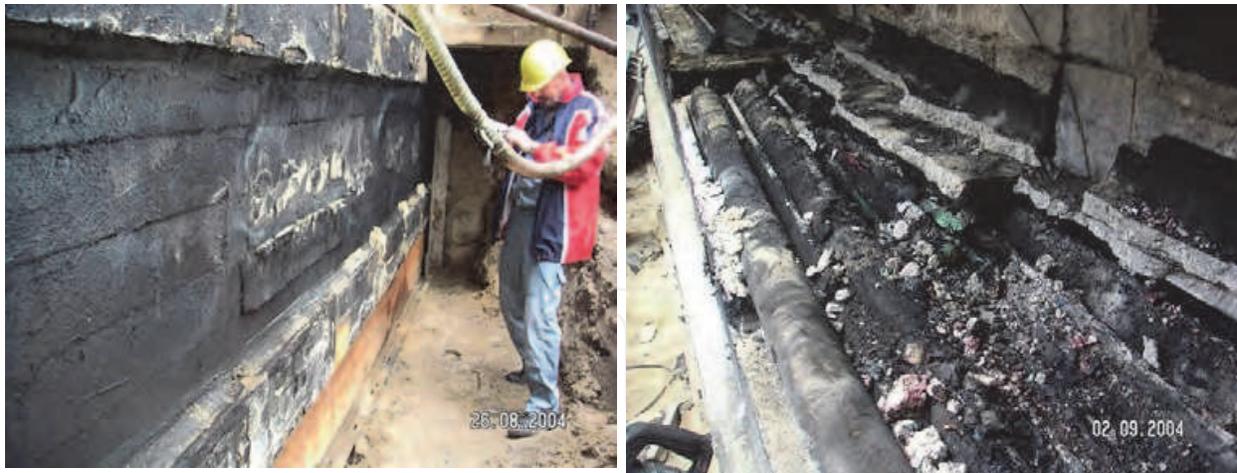
Fig. 3. Photos of the cable damage; left: location of the damaged cable, right: damage by the cable fire/evaporation

The detailed analysis led to the definite result that the event was mainly caused by ageing of the 10 kV cables. The ageing process was accelerated by the insufficient heat release inside the cable cylinder blocks.

As a corrective action, all high voltage (mainly 10 kV) cables with PVC shielding being older than 30 years were replaced by new ones.

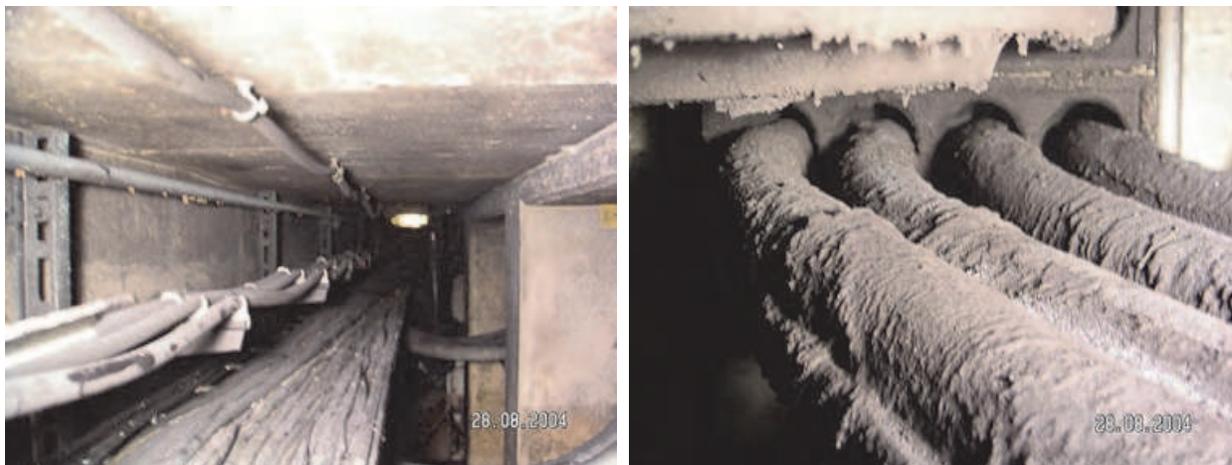
Fig. 4. Cables with protection by intumescent coating; left: photo of the cable channel, right: photo of the coating

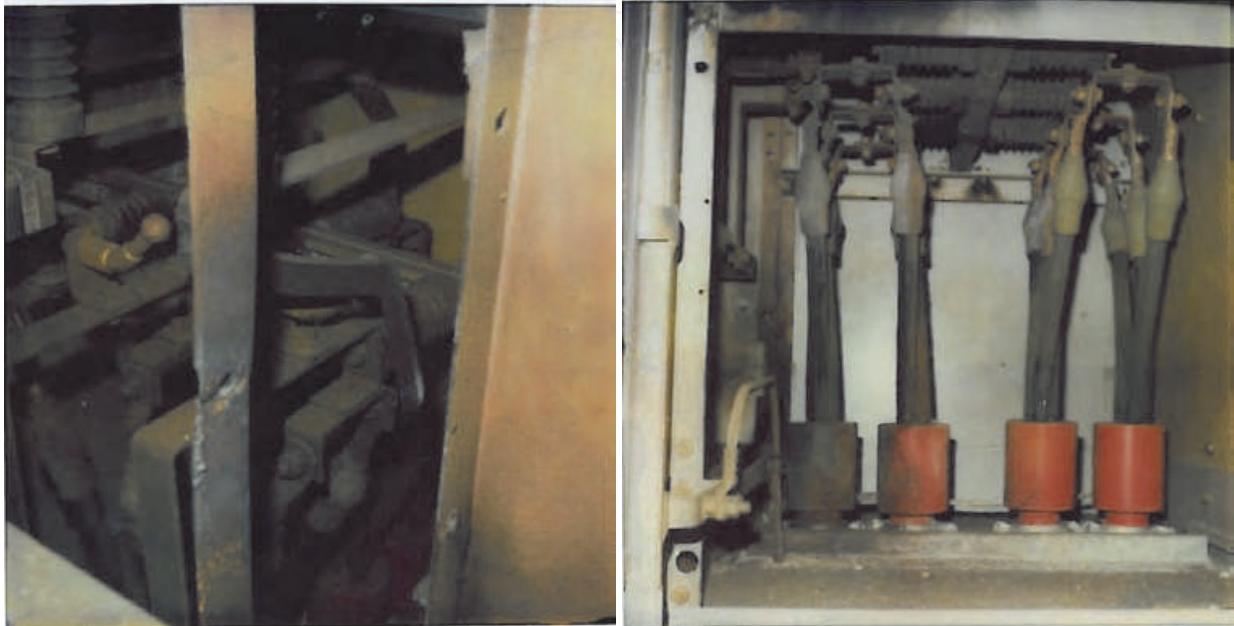
Fig. 5. Photographs: a) view into the exciter cabinet, in the foreground location where the screw loosened and b) view into the cabinet

Performing a load test during a regular in-service inspection (usually at an interval of four weeks) of the emergency diesel generator, an arcing fault with a short-to-ground took place in the electrical cabinet of the exciter system of the emergency diesel generator (cf. Figure 5 above).

The ground fault is assumed to be caused by a loose screw. The ionization of air by the arc developed to a short circuit within approximately four seconds.

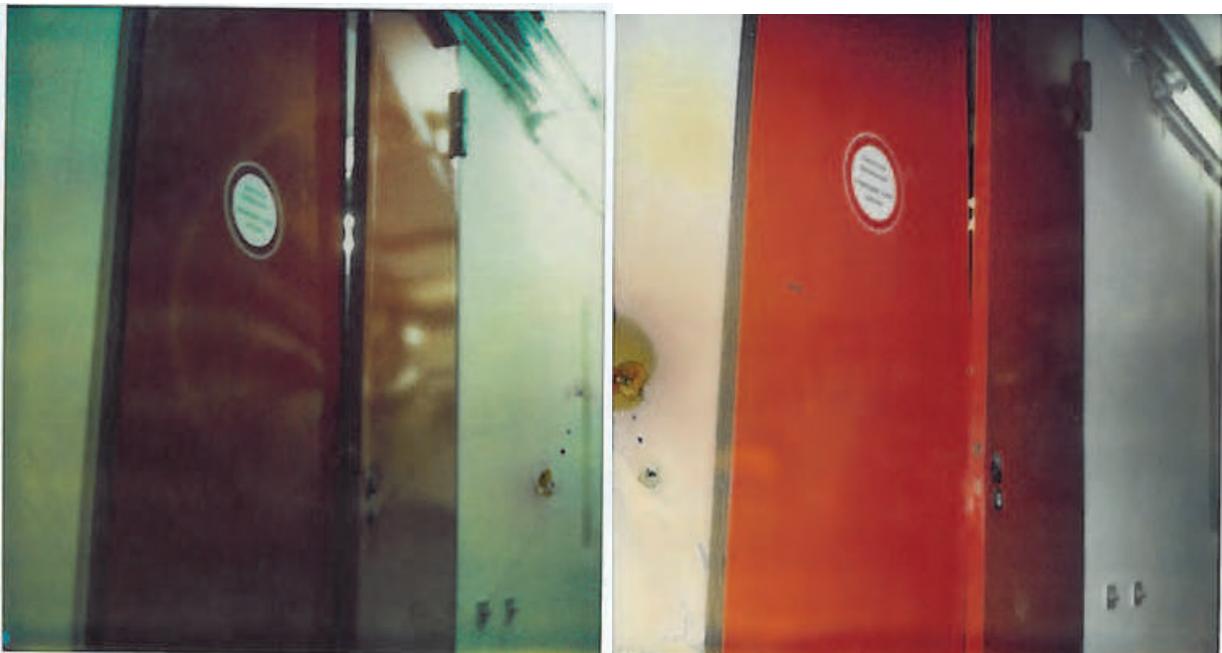
Fig. 6. Photographs of the damaged fire door from outside the room

Due to the high energy electric arcing fault a sudden pressure rise occurred in the room (room dimensions are approximately 3.6 m x 5.5 m x 5 m) that damaged the double-winged fire door.

Photographs of the damaged fire door from outside the room are shown in Figure 6 above.

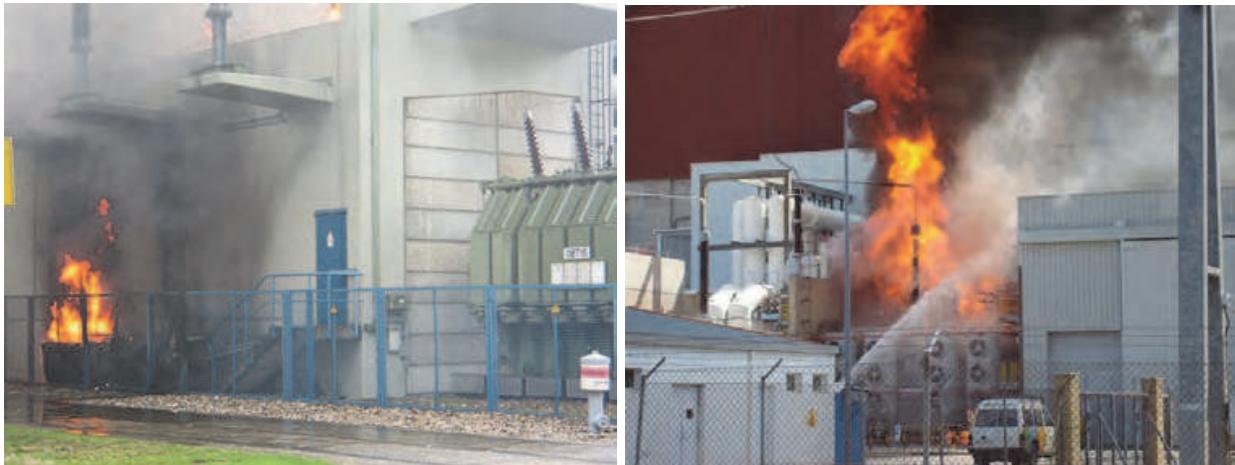
Due to the damage caused by the fire in the transformer, the plant was shut down. The fire of the transformer showed the normal behaviour of a big oil-filled transformer housing, the fire lacks combustion air and produces a large amount of smoke (see Figure 8).

A detailed root cause analysis regarding the different deviations from the expected event sequence was carried out. The cause of the fire was a short circuit in the windings of the generator transformer. Due to the damages to the transformer it was not possible to resolve the failure mechanisms in all details.

Fig. 8. Flame and smoke occurring at the generator transformer; the photo on the right hand shows the fire extinguishing activities

As a consequence of these indications, improvements concerning the fire protection of transformers are intended in Germany (Berg et al., 2010).

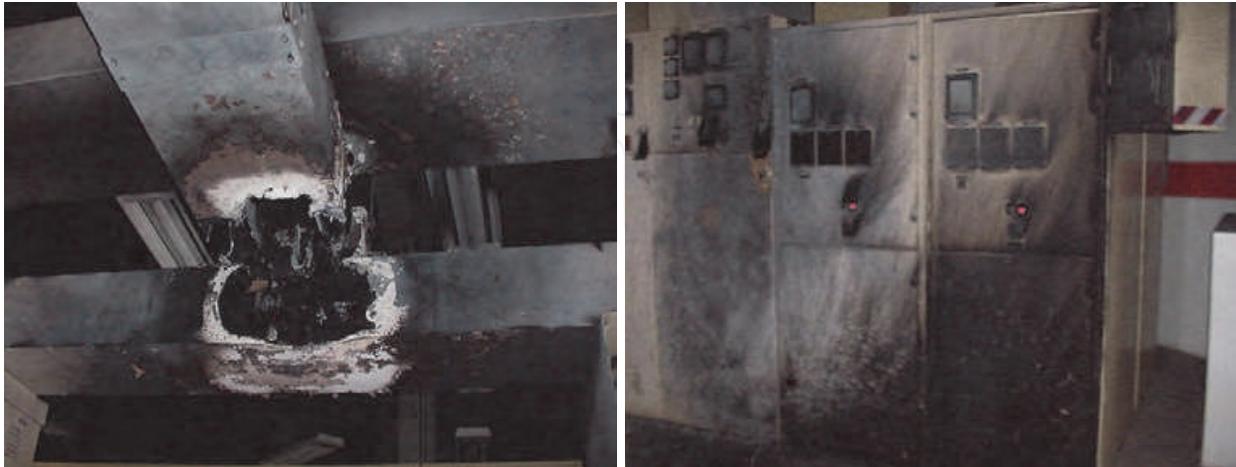
This event was initiated due to the centre bus overheating causing the polyvinyl chloride (PVC) insulation to smoke, which lead to a failure of the adjacent bus insulation. Having only a thin layer of silver plating on the electrodes, noticeably flaking off in areas not directly affected by the arc, contributed to the high-energetic arcing fault event.

Other factors that caused the failure were heavy bus loading and splice joint configurations, torque relaxation, and undetected damage from a 1995 transformer explosion. Two photos of this failure are shown in Figure 9. More photos are provided in (Brown et al, 2009).

Fig. 9. Photographs of the damages at the Diablo Canyon nuclear power plant (from Brown et al., 2009)
