# Recent Landslide Damming Events and Their Hazard Mitigation Strategies

Ahsan Sattar and Kazuo Konagai  
*Institute of Industrial Science, University of Tokyo*  
Japan

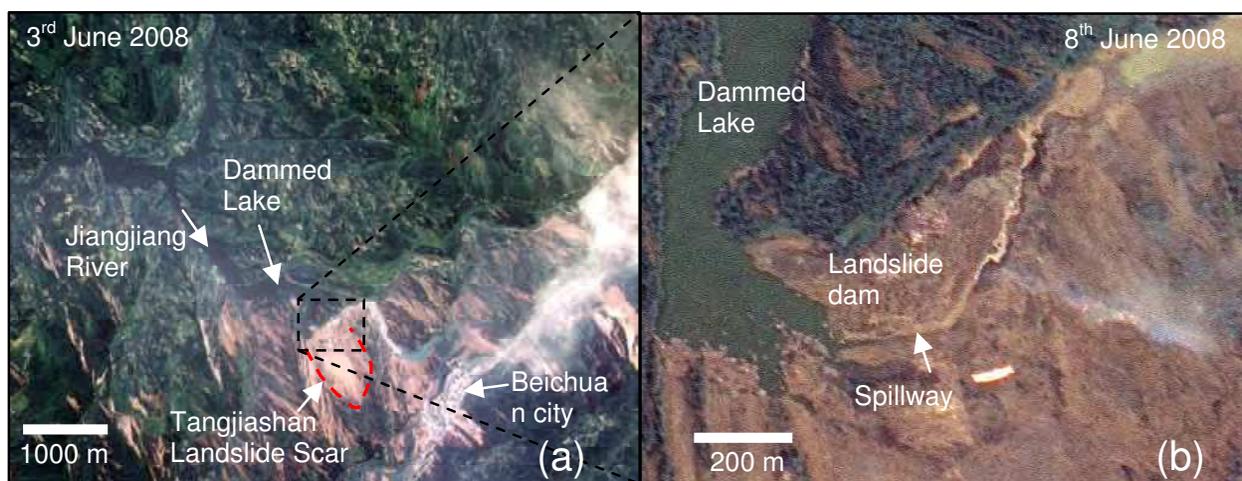
Fig. 1. True-color image of Tangjiashan landslide dam and dammed lake captured by NASA's Earth Observing-1 (EO-1) (a) on 3<sup>rd</sup> June 2008 prior to overtopping and (b) on 8<sup>th</sup> June after overtopping but before the breaching of dam

northern part of the fault zone, and impounded a lake on the Jiangjian River (Fig. 1). This lake behind the 124 m high landslide dam had a maximum storage capacity of 320 million  $m^3$  (Liu et al., 2010). The dam posed a great threat of flooding to the 1.2 million people living along the lower reach of the river, therefore required immediate mitigation measures.

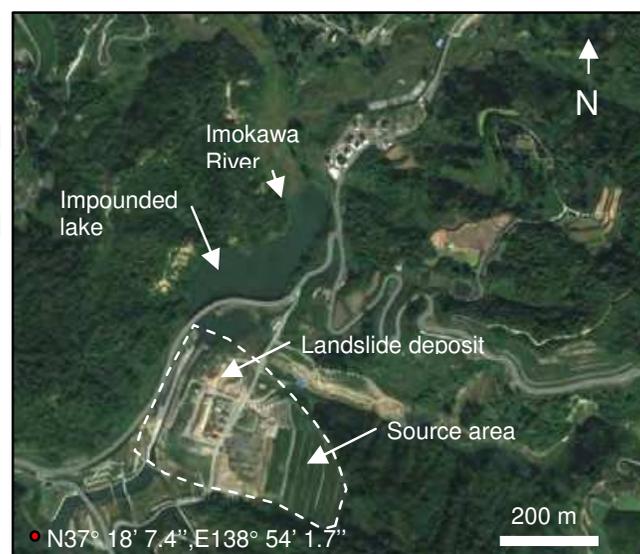
Fig. 3. Higashi Takezawa landslide dam and the dammed lake (Satellite imagery from Google Map)

landslide dam (N37° 18' 16.41", E138° 54' 16.13"), the largest landslide dam triggered by the earthquake (Fig. 3). The landslide originated from the left bank of the Imokawa River at Higashi Takezawa district. The landslide mass was about 350 m long and had volume up to 1 million m<sup>3</sup> (Sassa, 2005). The blockage started to impound a lake and soon the water started to inundate the Kogomo village. Due to the possible danger of overtopping and successive breaching of the dam emergency measure were taken to prevent the failure.

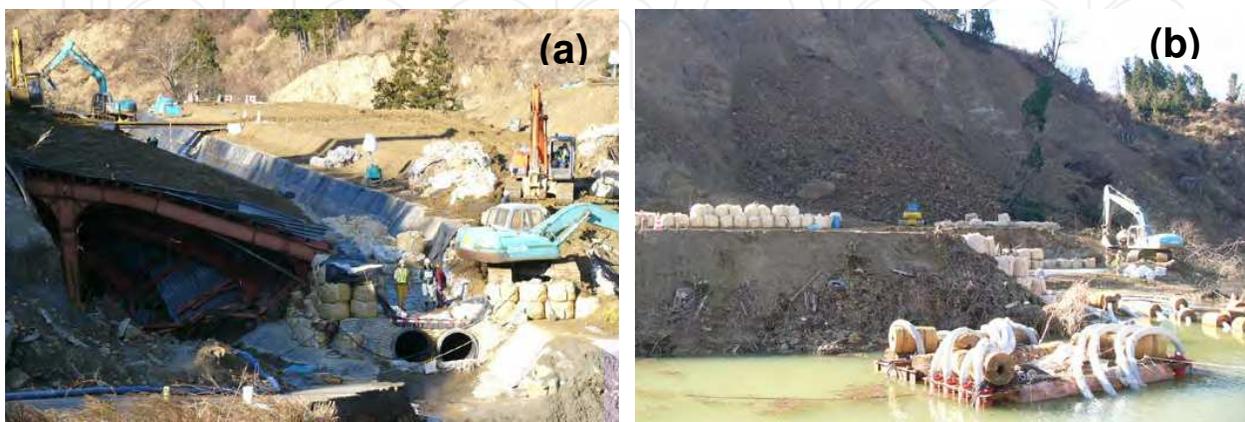
Fig. 4. Emergency works at Higashi Takezawa landslide dam. Photo taken on 20.12.2004 by Takeji & Tadashi, 2005

The following steps have been taken for stabilizing the landslide mass: twelve pumps were installed first to lower and keep the lake water level 11.5 m below the overflow point. In addition, the outflow level was raised by 3 m with sand bags at the outlet. Keeping in view the pumping power for this temporary system, diversion pipes were installed in case water overtopped the landslide mass (Fig. 4). Finally, a 280m long concrete-faced spillway was constructed with its cross-section large enough for snow melts.

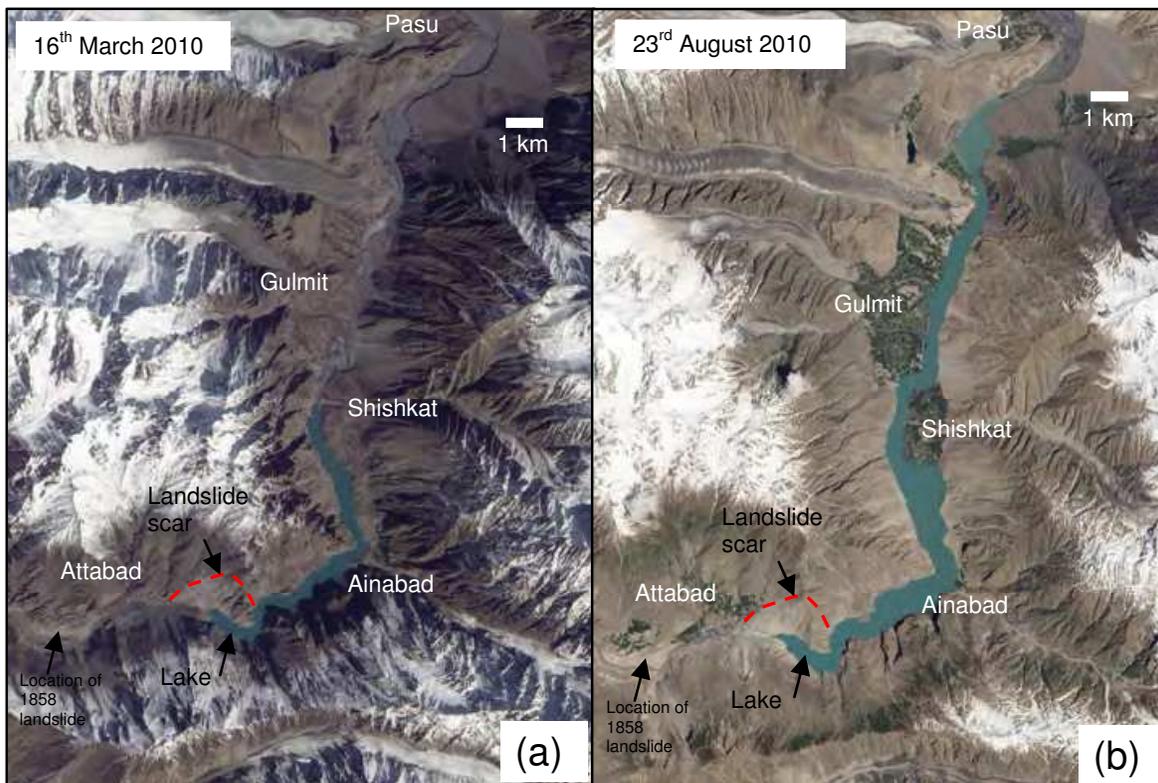
Fig. 5. The true-color image of the Attabad landslide dam ( $36^{\circ} 18' 50''\text{N}$ ,  $74^{\circ} 49' 13''\text{E}$ ) and lake captured by Advanced Land Imager (ALI) on NASA's Earth Observing-1 (EO-1) satellite, on (a) 16<sup>th</sup> March 2010 and (b) 23<sup>rd</sup> March 2010

A lake immediately started to develop at upstream of the debris mass. The impoundment created huge problems for the 25,000 people living at upstream of the landslide dam. Mitigation studies were conducted (Petley, 2010) and as an emergency repose a 30 m deep spillway was planned to be excavated to reduce the maximum possible volume of the lake. Seepage points emerged progressively at six different locations till April 2010. Meanwhile, closed circuit television, (CCTV) system was installed to issue a warning in case of much feared seepage failure. The excavation of the spillway started on 30<sup>th</sup> January 2010. The surface silty-clay deposit created problems during the excavation works as the construction machinery were bogged down with the muddy conditions at the site, and the work was stopped when the excavation had reached 15 m deep across the crest till 16<sup>th</sup> May 2010. The water started overflowing on 29<sup>th</sup> May 2010. At the time of overtopping the lake reached a length of 21 km and had an estimated volume of  $450 \times 10^6 \text{ m}^3$ . Fig 5a and 4b shows the true-color image of the Attabad landslide dam and lake captured by Advanced Land Imager (ALI) on NASA's Earth Observing-1 (EO-1) satellite, on 16<sup>th</sup> March 2010 and 23<sup>rd</sup> August 2010 respectively. About 25,000 people were cut off from the downstream population and are still suffering at the moment of writing.

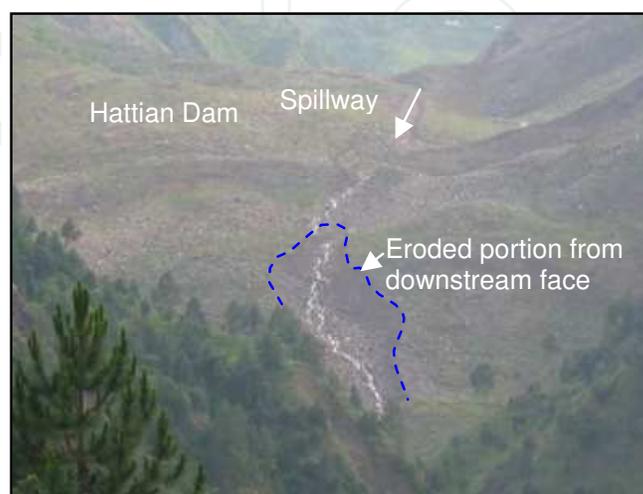
Fig. 7. Front view of the Hattian landslide mass, showing the downstream face erosion.

Gradual toe erosion was initially observed, which was then followed by a rapid head cutting erosion of the downstream face of the dam (Fig. 7). On 9<sup>th</sup> February 2010, the water of Karli Lake breached the debris dam after five days of incessant rain, and the breaching drained about 36 million  $m^3$  of water from the lake. According to the back analysis conducted by Konagai, et al., (2011) the peak outflow was about 5500  $m^3/s$ . A moderate 32 mm/day rainfall was estimated on the day prior to the day of breaching. About 7.78 million  $m^3$  of soil was estimated to have been eroded during the breaching event. The flushed debris mass was deposited along the Karli River. Fig. 9 shows the satellite image and profile of the Karli River before and after the breaching. A major portion of the eroded material is deposited over the approximately 2km downstream stretch from the dam along Karli River and less significantly beyond the stretch. The flow along the Karli River reached the depth up to 20 m. The debris deposit was about 40 m thick near the toe of the dam.

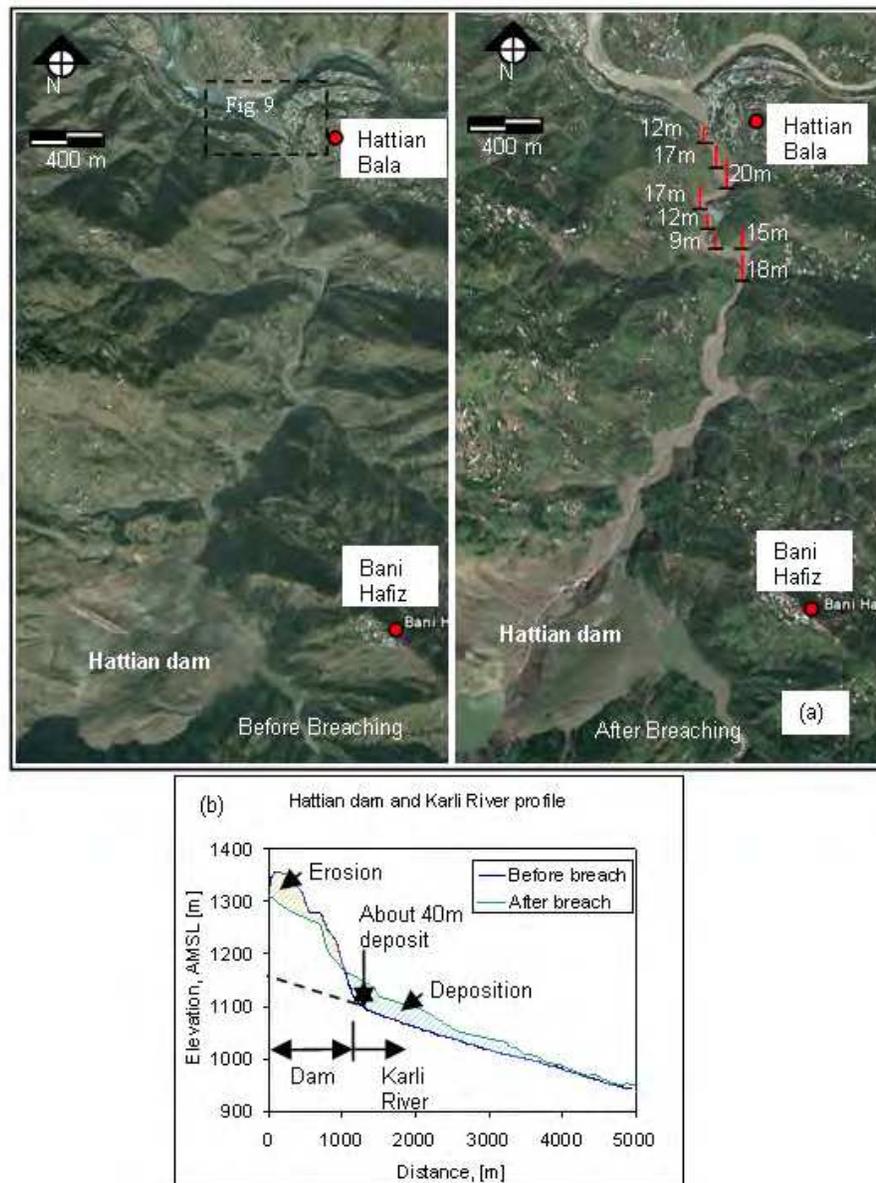
Fig. 9. (a) Satellite imageries of Karli River before and after breaching of Hattian dam (Google Earth), along with the maximum flow depths measured along the Karli River after failure of the dam (b) Profile of Hattian dam and Karli River before and after breaching of the Hattian dam

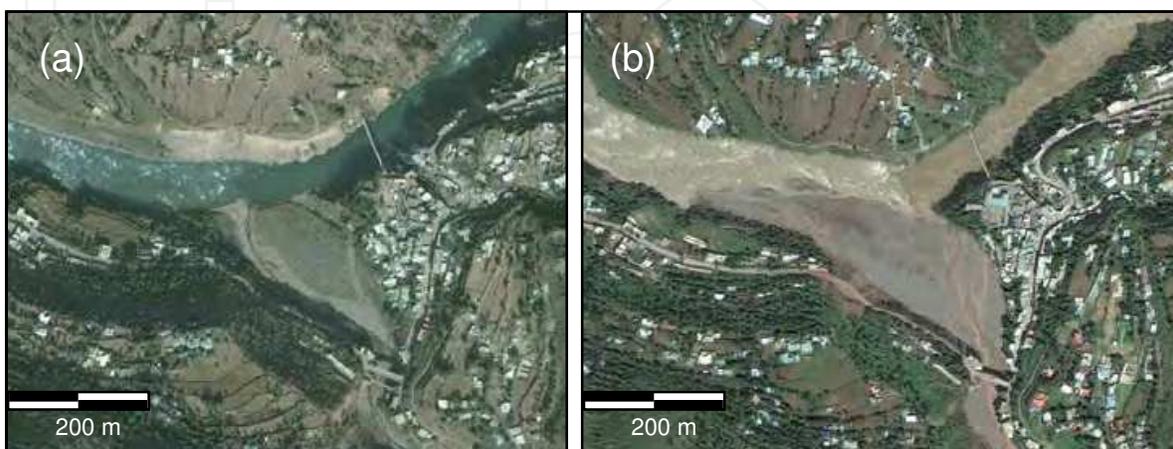
Fig. 10. (a) Satellite image of the junction of the Karli River with the Jhelum River before and after the breaching of Hattian dam (Google earth)

The dam break flood and debris destroyed one bridge near the junction of the Karli River with the Jhelum River and damaged about 24 houses as shown in Fig. 10. However major damage from the dam breach occurred as a landslide on the right bank of the Karli lake that was triggered by emptying of lake water. The figure 11 shows the satellite image of the right bank landslide after the breaching event, along with the contour map of the landslide and longitudinal profile of the landslide. This landslide destroyed 174 houses forcing about 1000 residents to evacuate.

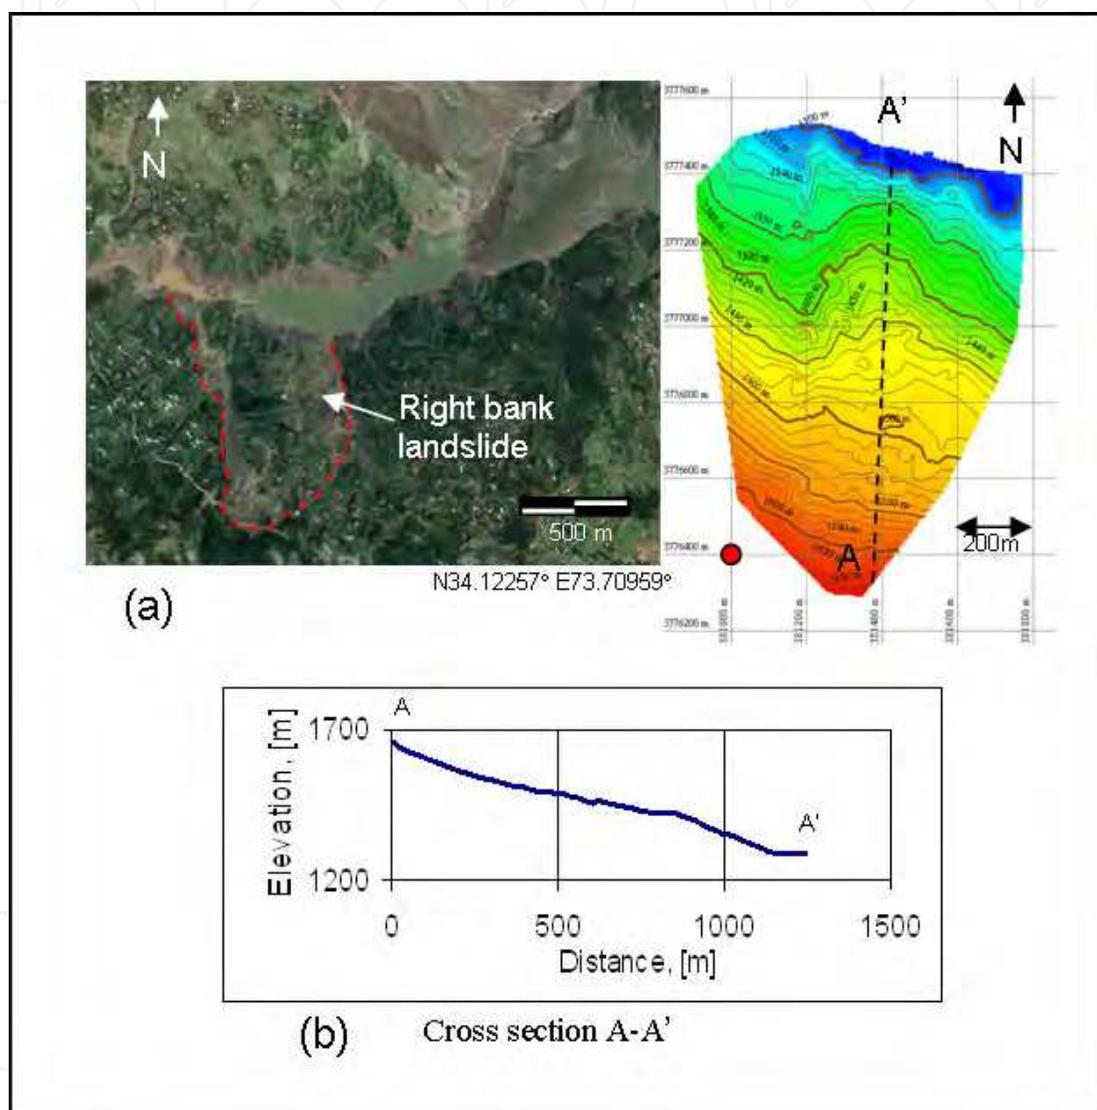
Fig. 11. (a) Satellite image of the Hattian landslide dam, Karli lake and the right bank landslide after the breaching event, along with the contour map of the landslide, (b) the longitudinal profile of the right bank slide. Modified from Konagai et al., 2011

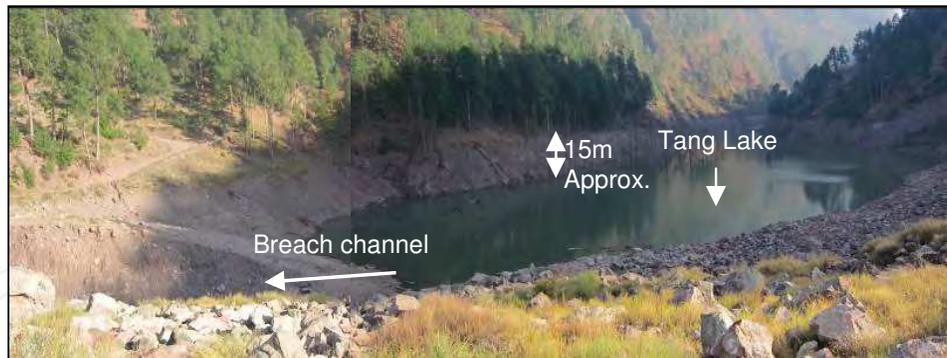
The Tang Lake breached during the monsoon rains (July-August) of 2010. In the breaching process, the water from Tang Lake eroded the north-eastern end of the landslide lobe, which had been covered with boulders segregated up at the time of deposit, and approximately 15 m depth of the lake water was drained leaving 1.9 million  $m^3$  water in the lake (Fig. 12).

Fig. 12. Tang Lake after breaching (Photo taken on 6<sup>th</sup> Dec-2010). From Konagai et al., 2011
