Glenoid Loosening in Total Shoulder Arthroplasty

Nahum Rosenberg, Maruan Haddad and
Doron Norman

<http://dx.doi.org/10.5772/53438>

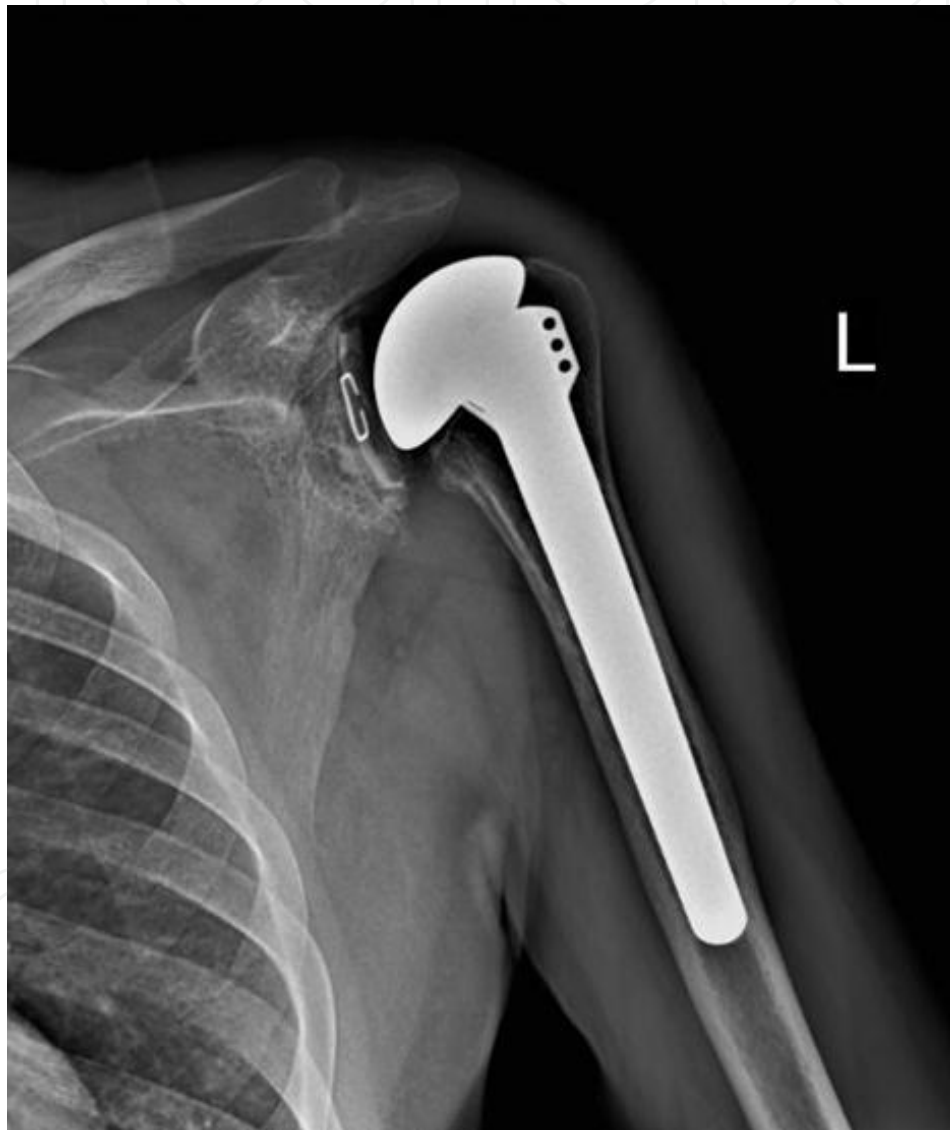
Figure 3. A shoulder radiograph (anterior-posterior view) of 60 years old male patient, three years after cemented TSA. Lucency is evident in the direct proximity to the glenoid component, but the patient is pain free and has good range of movements of the operated shoulder, without any laboratory evidence of infection and is satisfied from the function of the operated shoulder.

The clinical signs of the TSA prosthesis failure include an increased level of pain during follow-up, that appeared to be related to the implant, with restriction of external rotation to under 20° and abduction to under 60° and/or newly developed radiolucency at the glenoid component interface with the underlying bone, more than 2mm in width [17]. The recognition of coexistence of both physical and radiographic signs is essential, since the isolated finding of periprosthetic radiolucency, without pain or significant restriction of movements of the shoulder, might not be of a high clinical importance (Figure 3). This consideration
