# Influence of Immersion Lithography on Wafer Edge Defectivity

K. Jami, I. Pollentier, S. Vedula and G. Blumenstock

Source: Lithography, Book edited by: Michael Wang,  
ISBN 978-953-307-064-3, pp. 656, February 2010, INTECH, Croatia, downloaded from SCIYO.COM

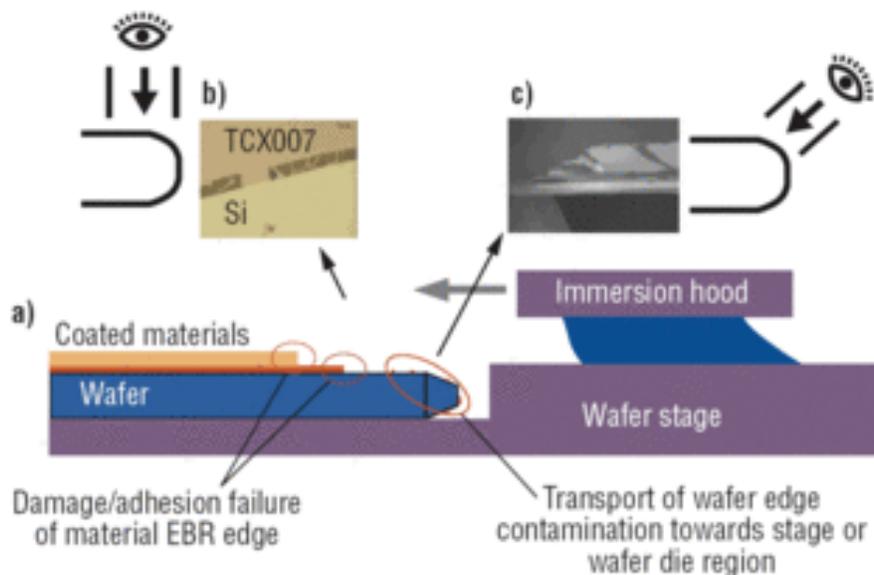
Fig. 1. a) Schematic representation of possible defect issues with immersion lithography; b) example of damaged photoresist material inspected with top-down optical microscope; and c) example of damaged residues at the wafer edge, inspected by tilted SEM (45°).

Immersion lithography [1-4] has changed the way we view defectivity issues at the wafer edge significantly. During the immersion exposure sequence, the wafer edge is in contact with the water from the immersion hood (IH), introducing additional concerns beyond direct contact of resist with the scanner. First, when the IH is scanning in the EBR region, its movement can damage material edges (Fig. 1a). IMEC's program on immersion lithography found that, for example, photoresist material can partially peel off during the IH pass (Fig. 1b).

A second concern involves the cleanliness of the wafer edge outside the EBR edges. The IH pass wets not only the near-edge top surface, but also the curved wafer edge and even part of the bottom surface. Defects can be released from this area and re-deposited either on the wafer or on the wafer stage. In the first case, there will be a direct impact on the wafer defectivity. In the latter case, defects present on the wafer stage can be transported onto wafers in subsequent wafer processing. IMEC's program on immersion lithography found that resist residues left on the curved wafer part by an incomplete EBR step can be damaged by the IH pass, releasing fragments into the system (Fig. 1c).

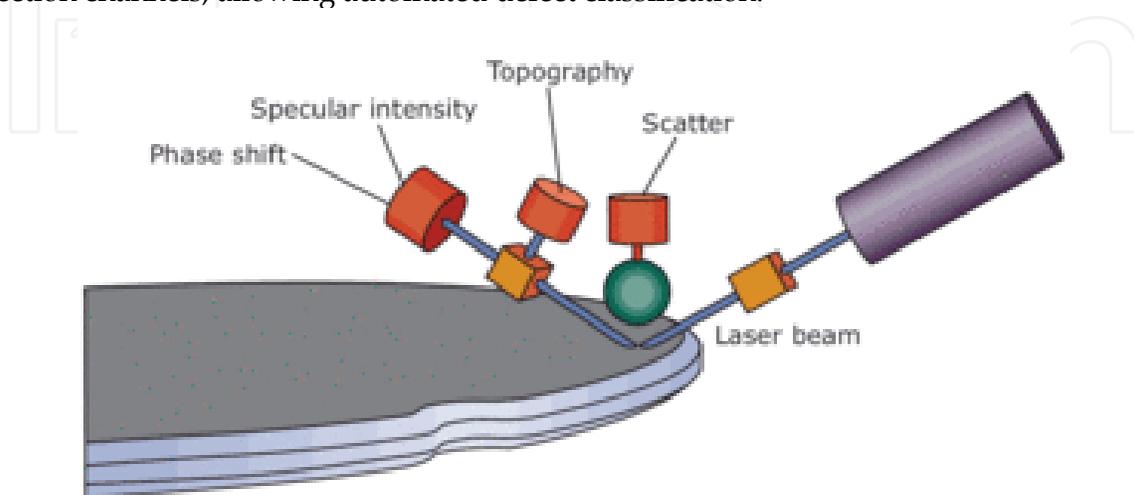
Fig. 2. Schematic representation of the VisEdge measurement principle.

The new measurement system for wafer edge defect inspection (Fig. 2) is based on a laser source directed to the wafer edge surface. Three detectors simultaneously collect the scattered light, the specular or reflected light and the phase difference between different polarization states. As the laser scans the wafer edge surface, each signal can be converted into an image. Each type of defect produces a specific combination of signals from the three detection channels, allowing automated defect classification.

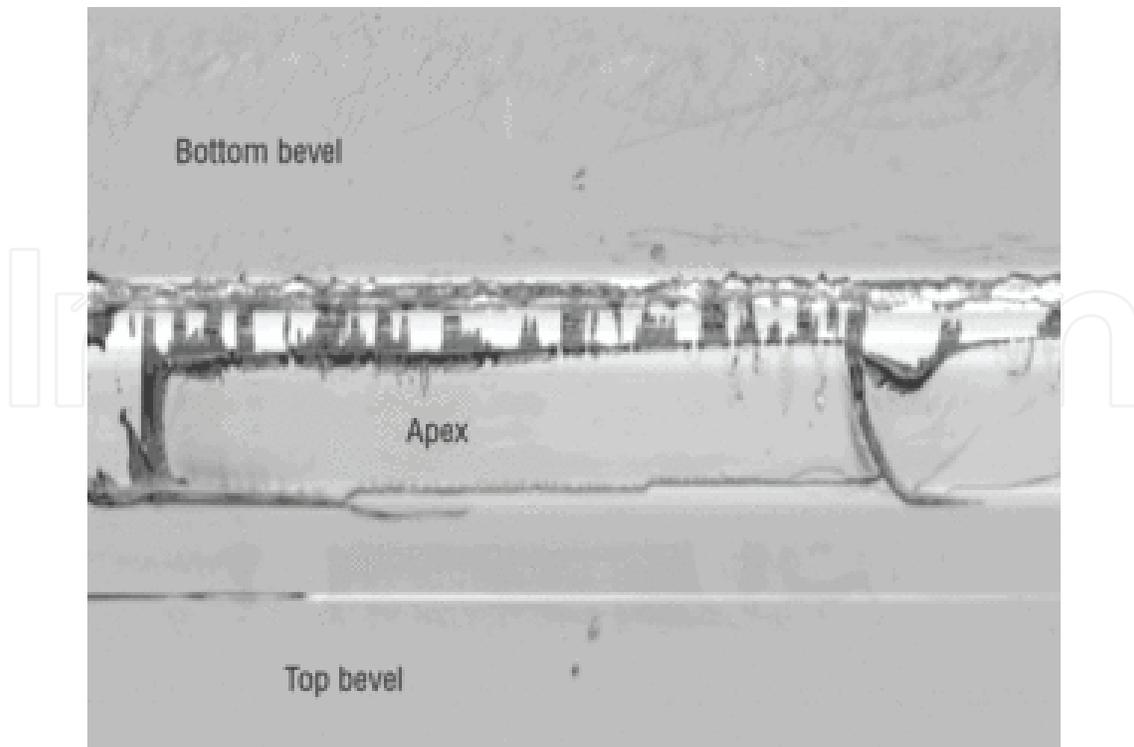
Fig. 3. Example of a specular image using the new technology showing part of the bevel/apex region. This kind of representation is valuable for the evaluation of wafer edge quality.

For wafer edge cleanliness, a high-resolution view of the wafer edge is typically more useful. Here, the images view only a few millimeter of the edge. Figure 3 uses this representation to show resist flakes observed along the apex-bevel regions in the specular channel.

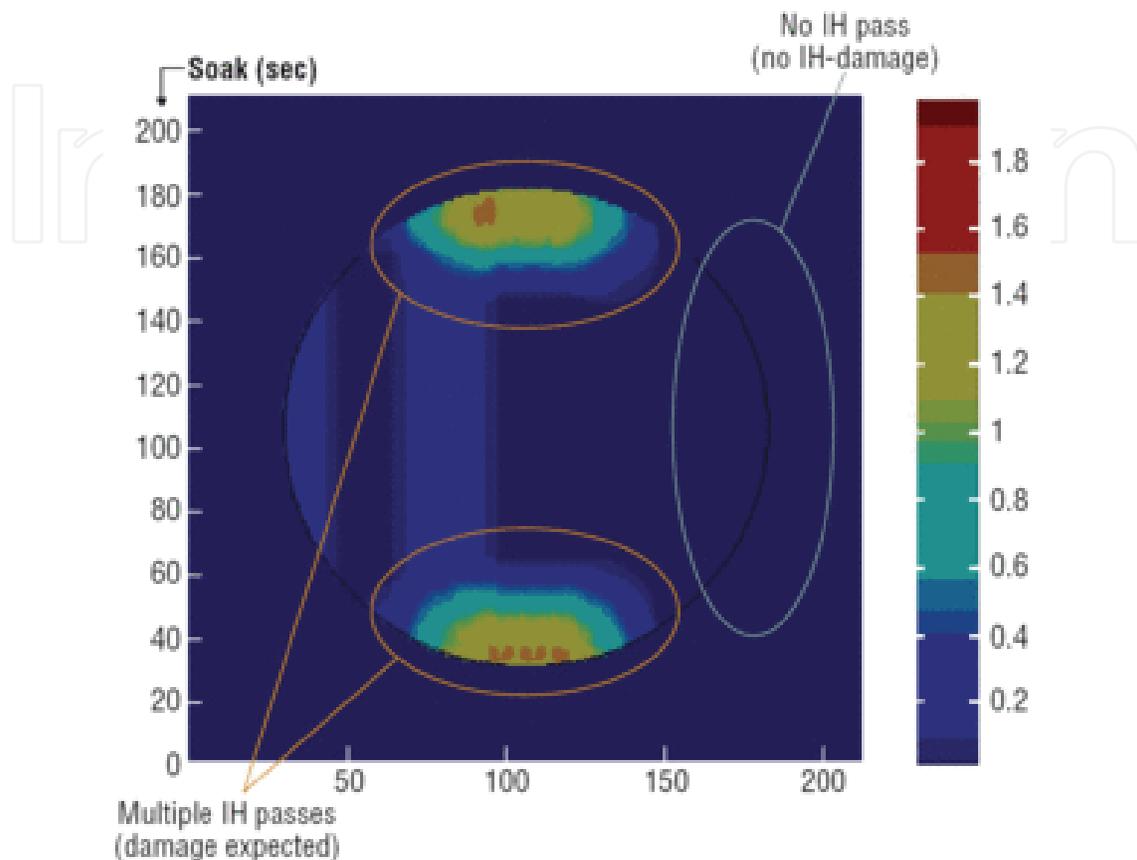
Fig. 4. IH exposure sequence for edge flake characterization.

We experimented with three resists with different chemistries (**Fig. 4**). Sensitivity to edge damage was expected to vary across the three resist types. A dedicated exposure job spatially separated the areas where flakes are expected and where they are not expected. One section, consisting of two rows of 11 fields, was exposed close to the wafer edge at the opposite side of the notch. A similar area of two rows of 11 fields was exposed in the region of the notch. During the exposure of these  $2 \times 11$  sections at both locations near the wafer

edge (Region II), the IH makes continuous up- and down-scans over the wafer edge area, increasing the probability of defect generation. The exposure job was also designed so that on another part of the wafer (Region I, on the right hand side), the immersion hood did not pass over the wafer edge. In Region I, no flake-like defects were expected.

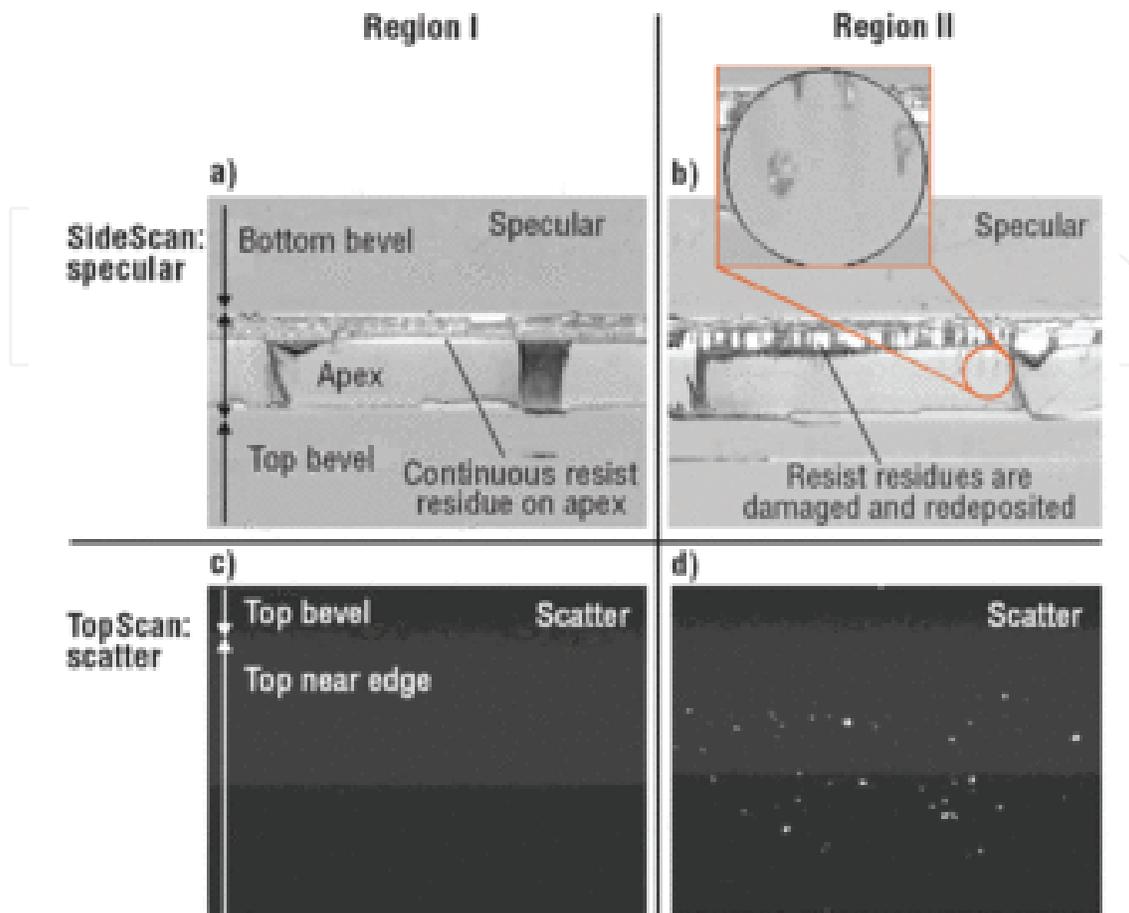
Fig. 5. Specular and scatter images from Region I (a and c) and Region II (b and d) of a test wafer. IH damage is more likely in Region II.

We compared the SideScan images of areas where the IH did and did not pass. Figure 5a is a typical SideScan specular image for region I (where the IH did not pass). Differences in thick and thin resist residues are visible, but no fragments of the resist residues are evident. In contrast, in Fig. 5b, taken from Region II, indicated that parts from the thick residue at the bottom of the apex were released. The close-up in the image indicates that some of these edge flakes were re-deposited on the apex closer to the top.

To determine whether any of these edge flakes end up on the top region (where edge die can be damaged), we analyzed the TopScan image of the corresponding areas of Fig. 5a and 5b using the scatter channel, as shown in Figs. 5c and 5d. In Region II, a lot of particles were detected, while in Region I, no particles were observed in the images. This observation was encouraging for further ADC work.

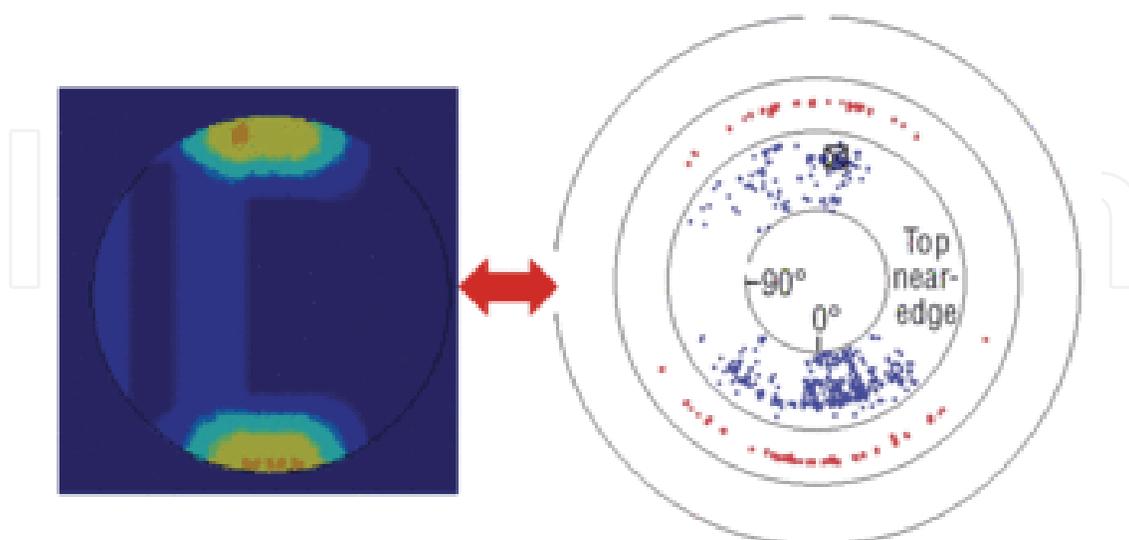
Fig. 6. Immersion characterization (quantification of edge flakes at wafer edge); the flakes on the apex and top near edge can be quantified by composite analysis of SideScan and TopScan signals.

channel of the SideScan image. For re-deposited defects in the top near-edge region, a combination of signals in the specular and scatter channels gave more accurate classification. Once all the measurement parameters for both areas are fixed, they can be combined in a single measurement sequence that provides defect classification and mapping for all the wafer edge areas of interest. (Fig. 6).

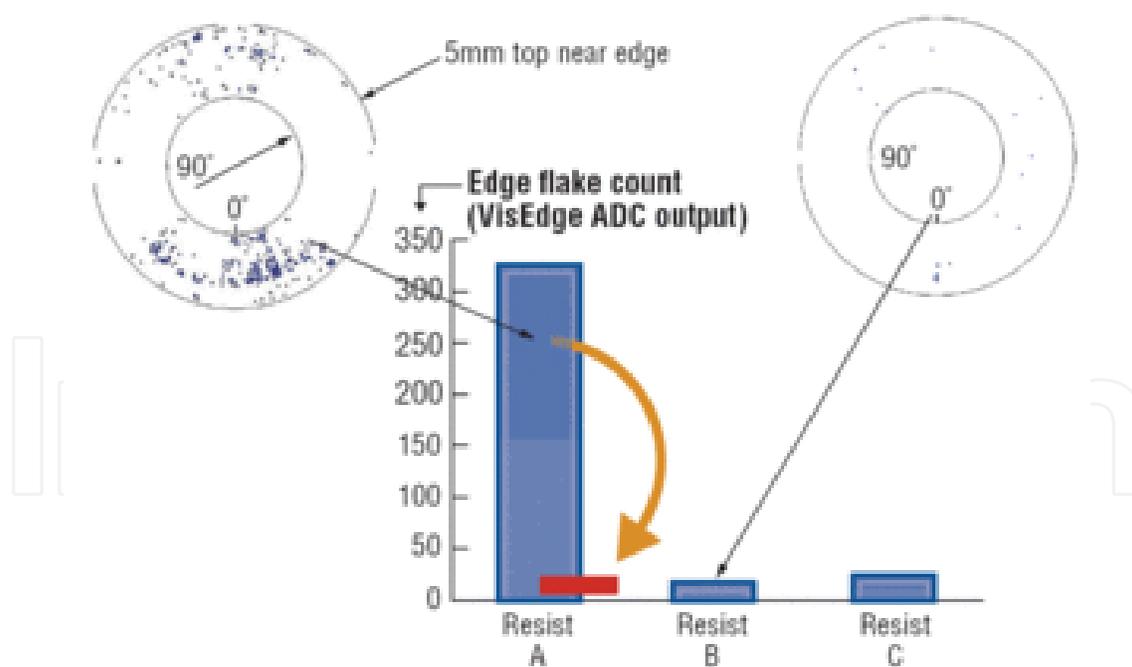
Fig. 7. Edge flake defects as a function of resist chemistry and EBR recipe.

When the same immersion exposure was used, significantly fewer edge flakes were detected in the near top region for Resist B and C than for Resist A (Fig. 7). Moreover, the residual defects were less confined to the exposure zone, so some of these defects might be caused by coating and wafer handling. In the TopScan images, no clear sign of damage was seen. Clearly the choice of resist chemistry can be important to prevent these kinds of defects.

As indicated earlier, resist residues can be optimized by changing the EBR recipe on the coat track. Resist A showed several hundred defect flakes with the regular (short) EBR sequence. After optimization, this resist achieved defect values similar to the background values obtained with the non-flaking resists B and C.
