# Investigation of High Energy Arcing Fault Events in Nuclear Power Plants

Heinz Peter Berg<sup>1</sup> and Marina Röwekamp<sup>2</sup>

## **Nuclear Power - Operation, Safety and Environment**

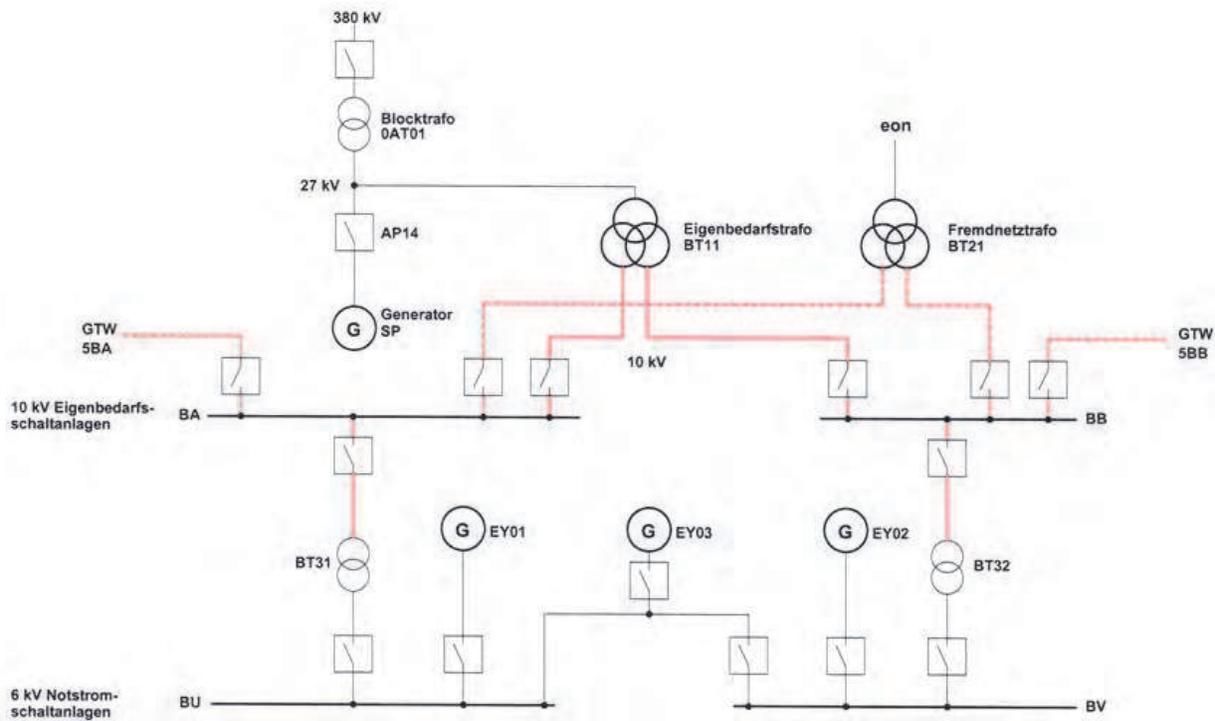
This event, which occurred in a 10 kV cable at a BWR type plant, has been analyzed in detail by the responsible expert organization on behalf of the regulator in charge (Berg & Katzer et al., 2009). Details on the electric circuit are provided in Figure 1.

Fig. 1. Scheme of the electric circuit affected

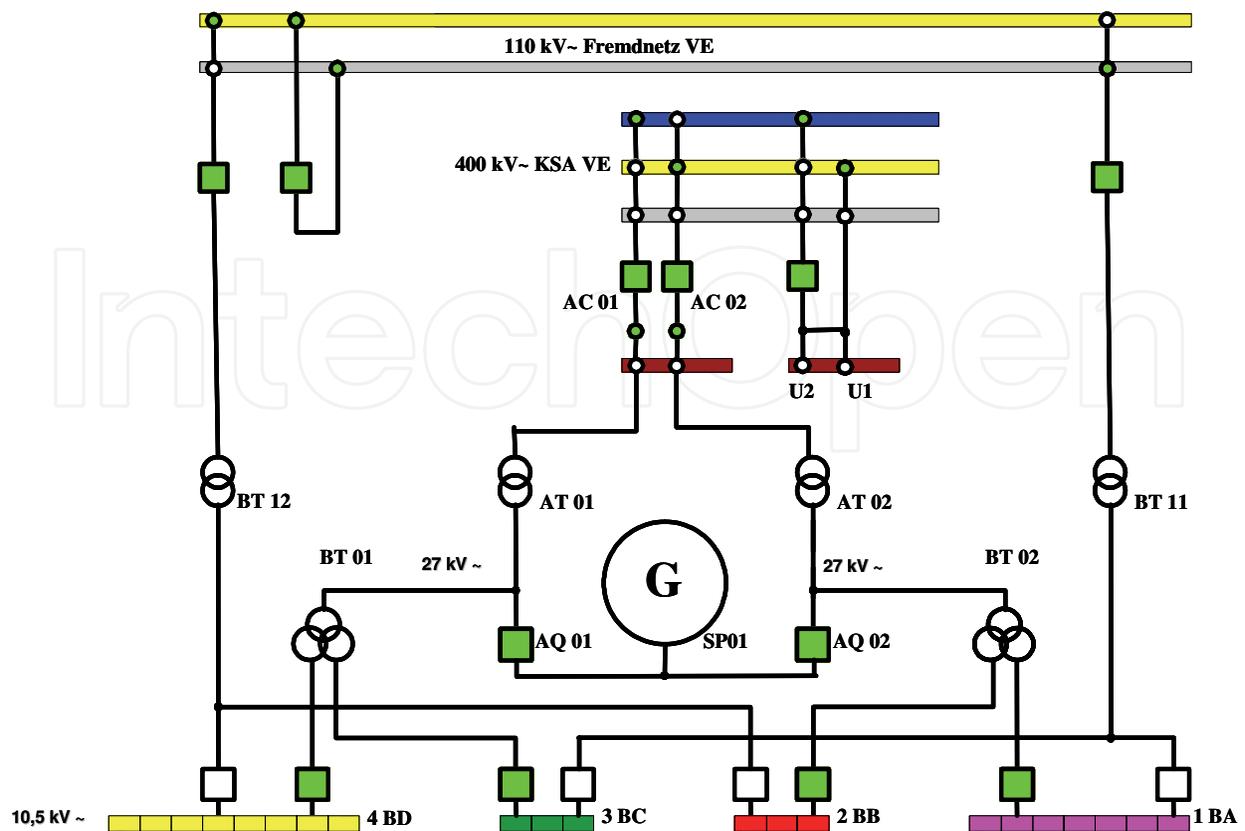
At the same time, de-excitation of the generator was actuated. The short circuit was thereby isolated. In addition, two of the four station service supply bus bars (3BC and 4BD) were switched to the 110 kV standby grid (VE). A simplified diagram is given in Figure 7 (Berg & Fritze, 2011).

Fig. 7. Simplified diagram of the station service supply and the grid connection of the nuclear power plant

A detailed root cause analysis regarding the different deviations from the expected event sequence was carried out. The cause of the fire was a short circuit in the windings of the generator transformer. Due to the damages to the transformer it was not possible to resolve the failure mechanisms in all details.

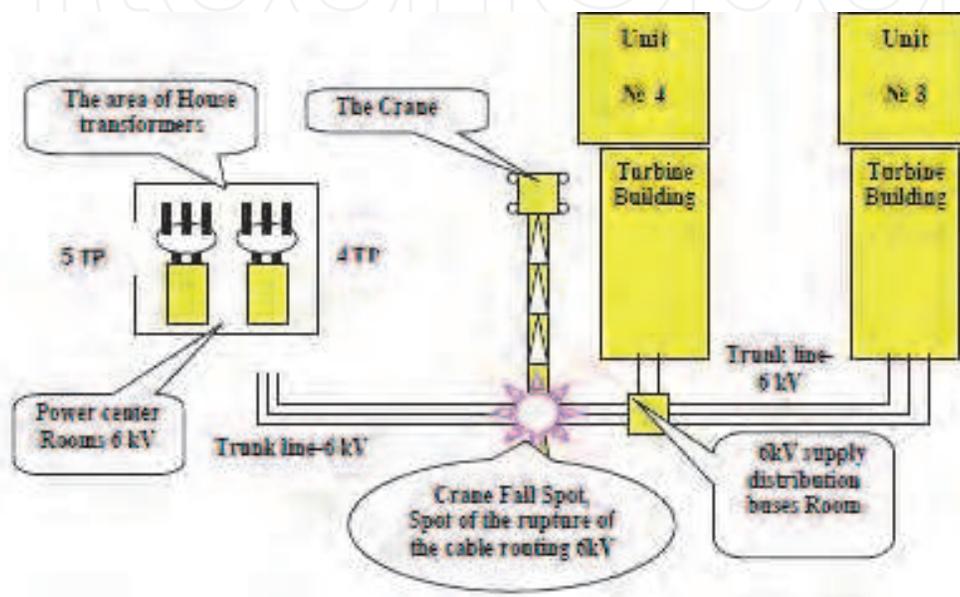
The event started when the jib of the crane fell on the trestle with the cables passed from 330/6 kV transformer TP 4 and TP 5 to unit 4 and broke them. The cables fell on the ground. The diagram of the situation after the event is provided in Figure 10 (IAEA, 2004).

The long-term exposure of this earth fault (1 min and 36 sec.) caused a high earth fault currents which burn the cables. This led to a fire spread to the 6 kV supply distribution buses and 6 kV metal clad switchgear rooms resulting inside these rooms in high temperature and release of the toxic substance. Also the equipment of the transformers TP 4 and TP 5 was damaged.

Fig. 10. Diagram of the situation after the event (from IAEA, 2004)
