# Recent Landslide Damming Events and Their Hazard Mitigation Strategies

Ahsan Sattar and Kazuo Konagai  
*Institute of Industrial Science, University of Tokyo*  
Japan

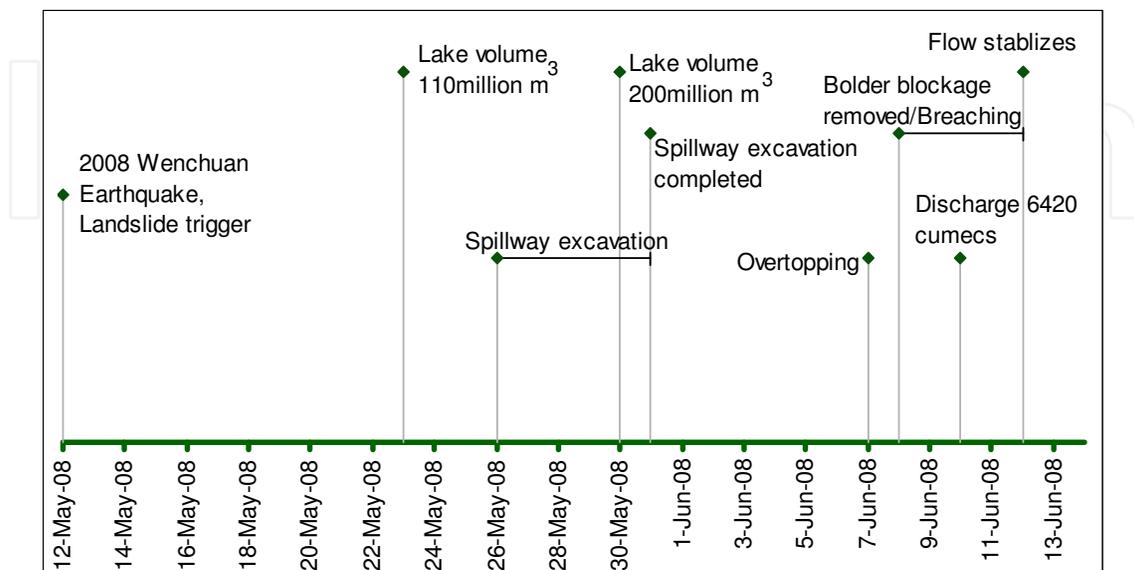
Fig. 2. Timeline of Tangjiashan landslide dam emergency response

total volume of the lake had reached 110 million  $\text{m}^3$  and then 200 million  $\text{m}^3$  till the end of May, 2008. The figure 2 presents the timeline of the Tangjiashan landslide dam emergency response. The lake hypsometric curve showed that if the lake level was kept at 740.3 m, the storage capacity of the lake would be reduced to 238 million  $\text{m}^3$  instead of 320 million  $\text{m}^3$  corresponding to the natural potential overtopping level of 755.0 m (Liu et al., 2010). Accordingly the civil works were carried out to excavate a spillway to minimize the potential dam breach damage. It took 7 days work from May 26 to 31, to excavate a 13 m deep and 8 m wide channel covering 475 m in length. The primary intention for the excavation of the spillway was to reduce the total volume of the lake and meanwhile to create a controlled flood to drain the lake. About 275,000 people evacuated from the downstream areas for the expected flood.

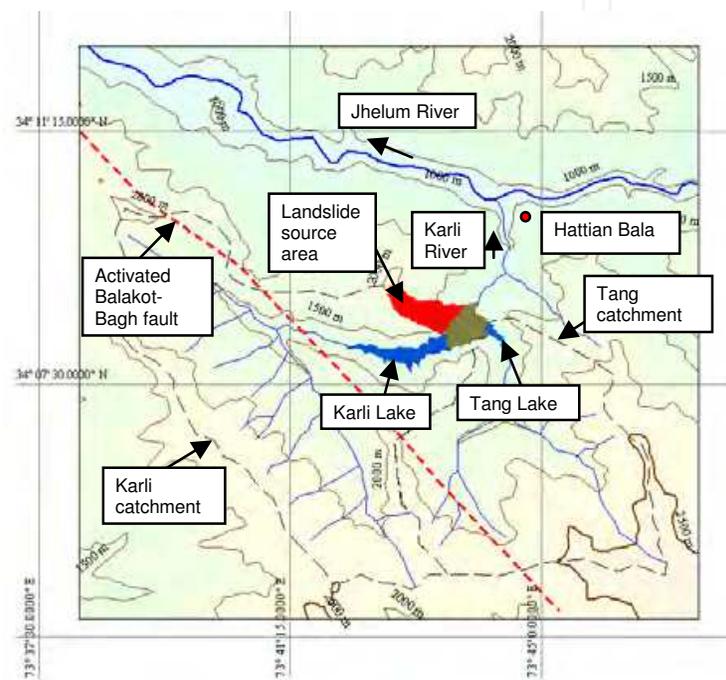
Fig. 6. Contour map of Hattian landslide, dammed lakes with their catchments and downstream areas.

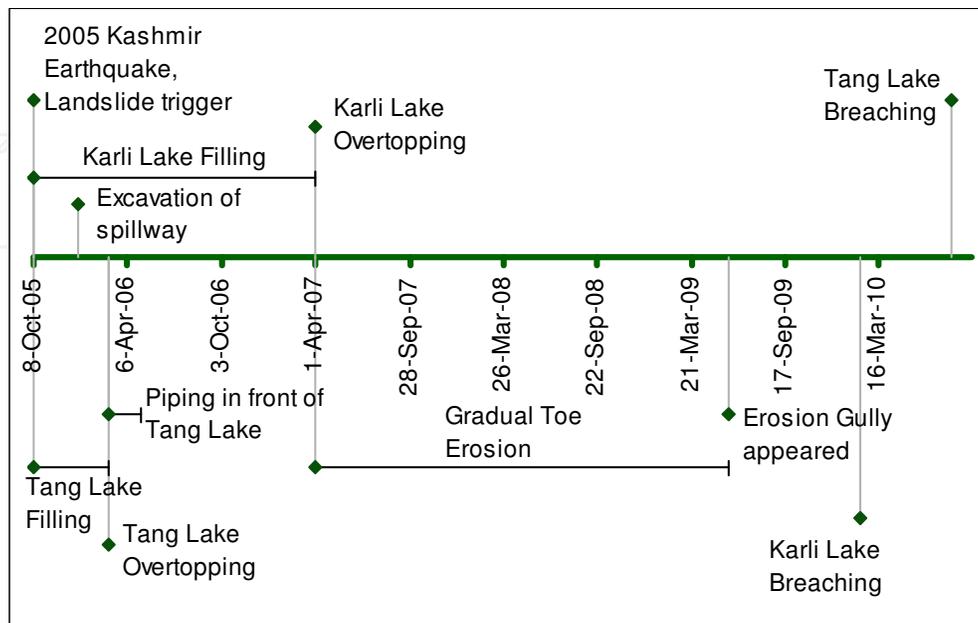
Fig. 8. Timeline of post formation features and major events at Hattian Bala landslide dam

million  $m^3$ . The Tang Lake filled up in February 2006 and started overflowing. A timeline of various events occurring at Hattian Bala landslide dam after its formation are presented in figure 8.
