Fatigue Characteristic of Automotive Jounce Bumper

Aidy Ali, R.S. Sidhu and M.S.A. Samad

*Department of Mechanical and Manufacturing Engineering
Faculty of Engineering, Universiti Putra Malaysia
43400 Serdang, Selangor,
Malaysia*

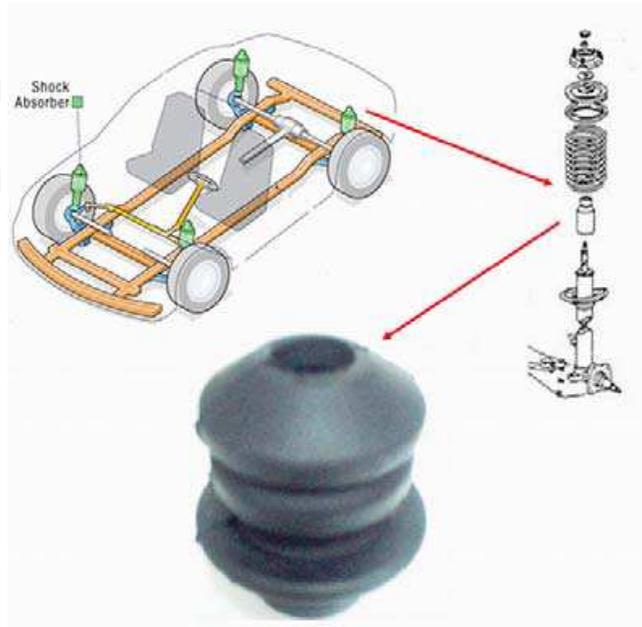
Fig. 1. Jounce Bumper in light automotive vehicles

Rubber components deteriorate much faster under fatigue loading compared to static loading. This is due to the fact that repetitive fatigue loading accumulates more damage and causes components to fail at a faster rate. This study was undertaken on a rubber jounce bumper which is a part of the McPherson strut assembly in chassis suspension system. It acts as a damper making the suspension progressive by allowing a smooth transition to full compression (Harza & Nallasamy, 2007). Figure 1 shows a typical jounce bumper use in light vehicles. There are two approaches commonly used to predict the fatigue life of rubber, the crack nucleation approach and the crack growth approach. Crack nucleation approach defines the failure as the number of cycles needed to cause a noticeable crack of a new component. Crack growth approach monitors the growth of a pre-existing crack (Mars & Fatemi, 2002; Saintier et al., 2006). Other than appearance of crack, load drop is used to acknowledge the existence of fatigue. Stiffness base approach is defined as the failure of a specimen at the point where the load drops at a significant amount usually 15 - 20 %. Researchers including Harbour and Kim use the load drop method as a failure criterion to acknowledge fatigue failure (Kim et al., 2004; Kim & Jeong, 2005; Harbour et al., 2008). Investigations on the cause of failure due to fatigue can be further explored using Scanning Electron Microscopy (SEM) embedded with Energy Dispersive X-ray Spectroscopy (EDS).

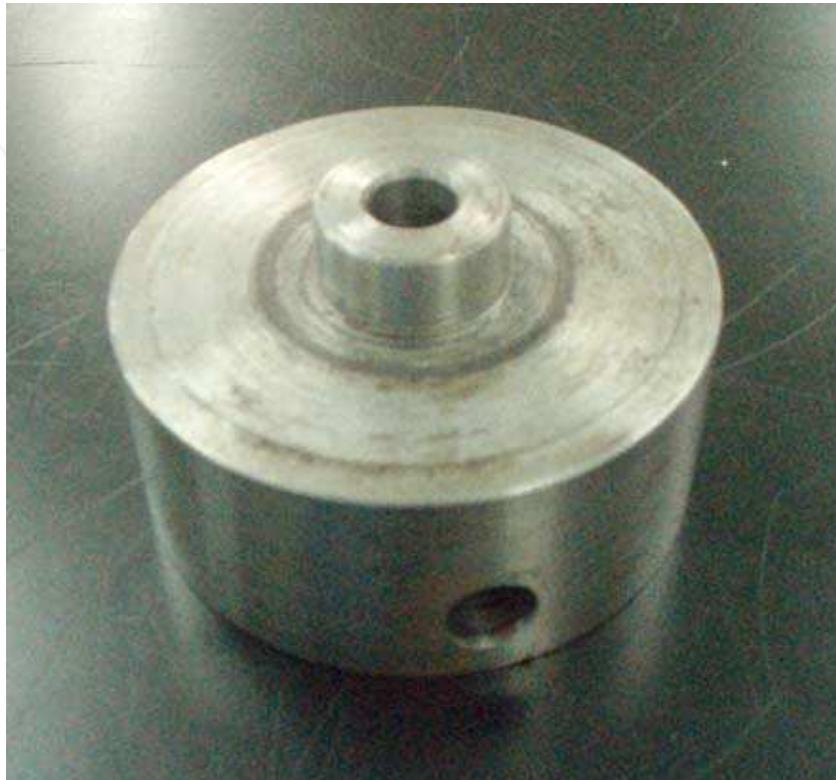
Fig. 2. Jig

A jig made out of mild steel is design to accommodate the loading condition by allowing the air to flow out while the jounce bumper is compressed. It also mimics the shock rod where it keeps the jounce bumper in line and prevents slips. The jig is shown in Figure 2.

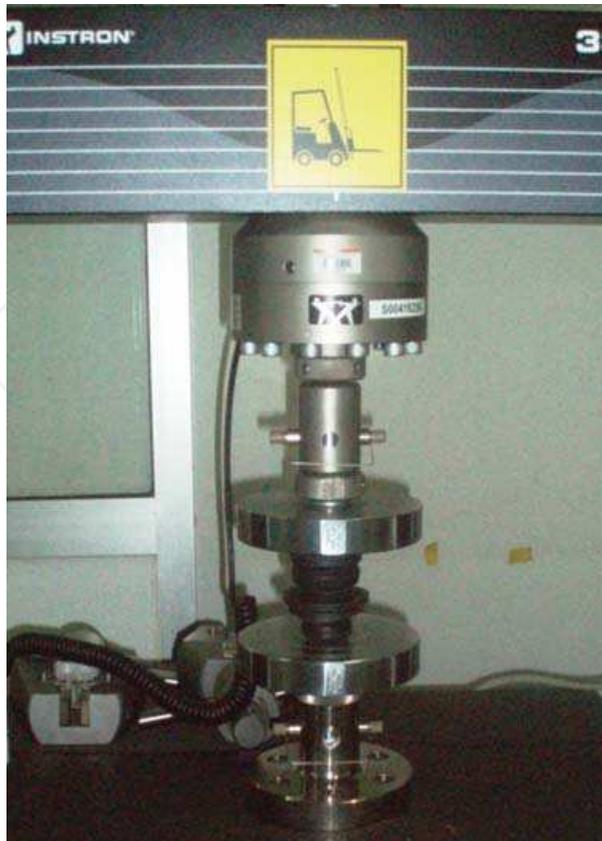
Fig. 3. Instron 3382 Floor Model Universal Testing System

The monotonic compression test was conducted using the Instron 3382 Floor Model Universal Testing System as shown in Figure 3. The test was done at a rate of 10mm/min to determine the maximum force of the jounce bumper and to obtain the Load versus Deflection response (L-D). For the fatigue compression test, twelve samples with different displacements were tested in an ambient temperature of 20 °C. The tests were carried out using the Instron 8871 table top model fatigue systems (Figure 4) with a sine waveform at frequency of 2 Hz at a load ratio of 0.

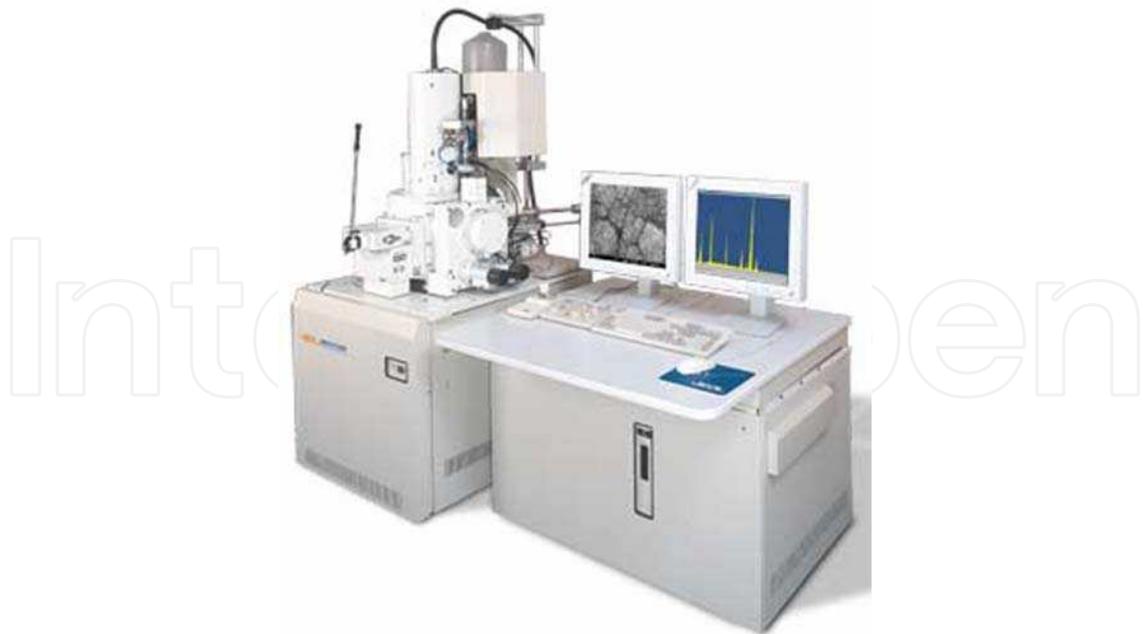
Fig. 5. JEOL FE-SEM JSM-6701F

The jounce bumpers were cycled for 30 rounds to eliminate the Mullins effect before the number of cycles to failure is taken into consideration. Mullins Effects can be described as an initial softening that occurs at the start of the fatigue test (Diani et al., 2009). The determination of fatigue failure is based on the 15 % load drop. For the SEM and EDS testing, the samples were cut from the failure surface (after fatigue) and also a controlled surface (before fatigue) and placed onto specimen stub with carbon double-sided tape. Then the specimens were coated by evaporative coating with ultra-thin layers of Platinum under high vacuum. This process creates a conducting layer that permits SEM examination to take place. The JEOL FE-SEM JSM-6701F as shown in Figure 5, was operated at 20 kV with 15 mm working distance. For elemental analysis, Energy dispersive x-ray (EDS) was used.

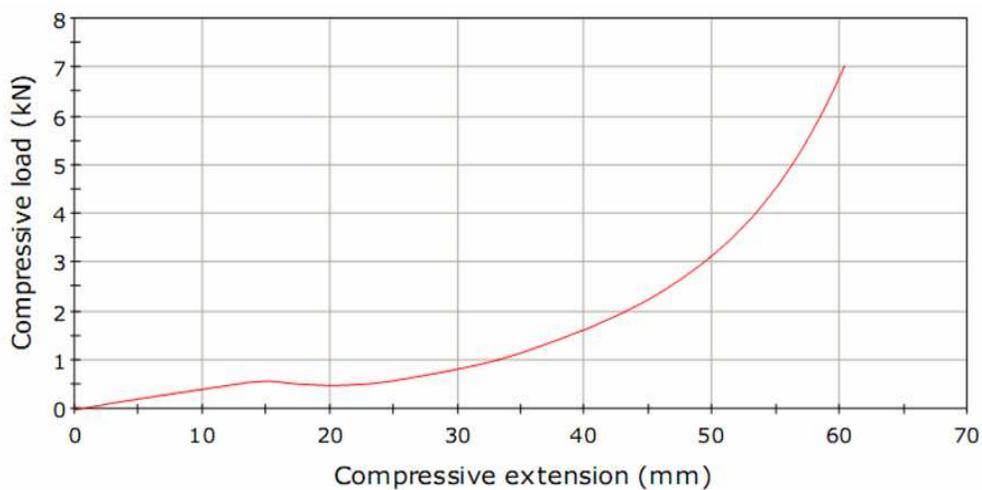
Fig. 6. Compression result

A load versus deflection curve was plotted from the compression test and shown in Figure 6. The test recorded a maximum force of 7 kN at 60 mm deflection. This shows that the jounce bumper is able to withstand a maximum load of 7 kN. Even though the jounce bumper is capable of handling high loads, it's unlikely for it to experience such loads in normal driving conditions. The optimum load experience by the jounce bumper is in the range of 0.5 - 2 kN (Harza & Nallasamy, 2007) as highlighted in Figure 6.

The fatigue characterization of the automotive jounce bumper was successfully determined. The compression test reveals that the jounce bumper is able to withstand a maximum force of 7 KN. From the fatigue test conducted, we were able to characterize the jounce bumper depending on the strain acted upon it. Three zones were established to separate the safe zone from the potential danger zone. FEA simulation using Abaqus successfully predicted the point of failure which matches the experimental results. Pre-existing flaws accelerates the initiation of cracks under fatigue loading. The SEM result proves that the virgin jounce bumper have decohesions. Type of material used to fabricate rubber components as well as the process of producing the component plays an important role in determining the quality of a product. In this case, the use of CaCO_3 and the mysterious existence of Aluminium compound reflect the poor quality of the rubber jounce bumper.

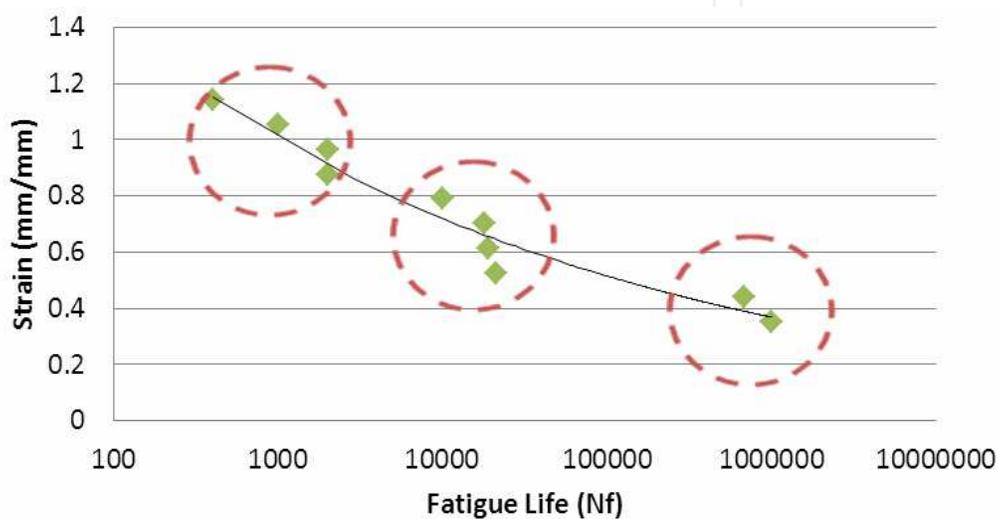
Fig. 7. Strain - Life (ϵ -N)

Figure 7 shows the strain versus fatigue life curve. The fatigue curve can be categorized into three zones. Zone one has the highest strain range between 0.88 - 1.14 mm/mm. Strains in this zone should be avoided at all cost as it yields very low fatigue life. Jounce bumper undergoing strains in zone two (0.53 - 0.79 mm/mm) will have a much longer fatigue life. However a regular replacement is necessary since it would not last for more than a 100000 cycles. Zone three is the safest zone with strains below 0.43 mm/mm. Strain values in this zone have fatigue life ranging from 675000 cycles and goes above 1.5 million cycles. Tests conducted on strains above 0.8 reveals significant fracture in the jounce bumper. The cracks originate from the lower part of the jounce bumper as highlighted in Figure 8.

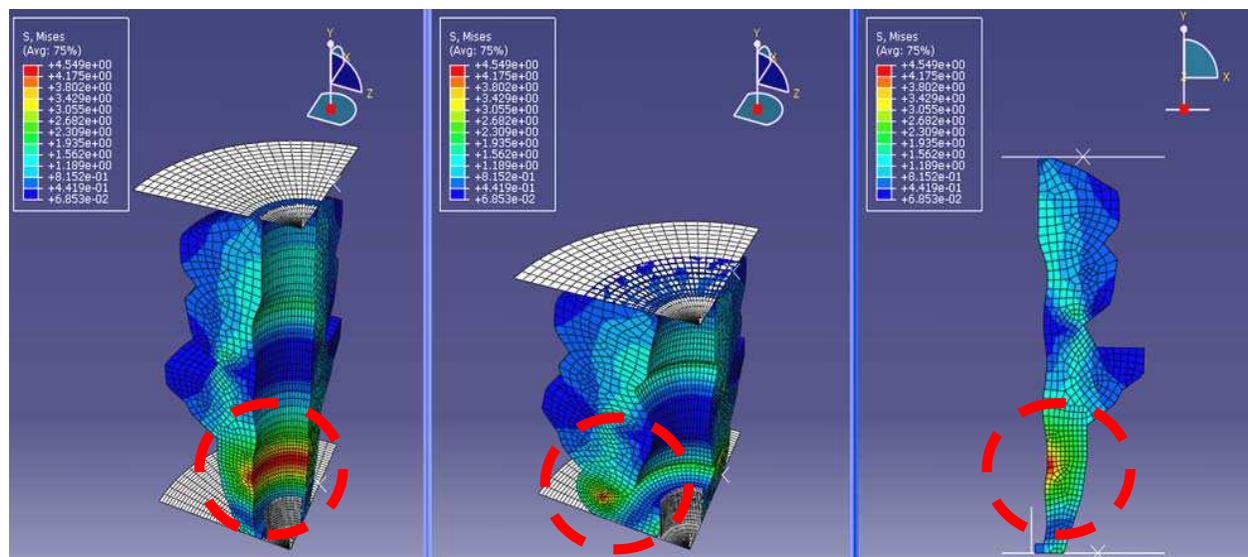
Fig. 9. Simulation of jounce bumper

To pin point the exact location of the crack initiation, simulation was done using Abaqus. Reverse engineering method was used to obtain the jounce bumper’s dimensions. The process involves the use of Coordinate Measuring Machine (CMM) and a 3D Scanner. The Neo-Hookean hyperelasticity model was chosen as the constitutive model for this analysis and constant was based on the experiment. Figure 9 shows the results of the simulation.

The simulation predicted the exact point of failure as the experimental results. The SEM micrographs are shown in Figures 10. Figure 10 (a) and (b) shows the control specimens at the crack location at x 150 and x 400 respectively while Figure 10(c) and (d) shows the failed specimen at the same location and magnification. The result from the elemental analysis using Energy dispersive x-ray (EDS) is shown in Table 2.

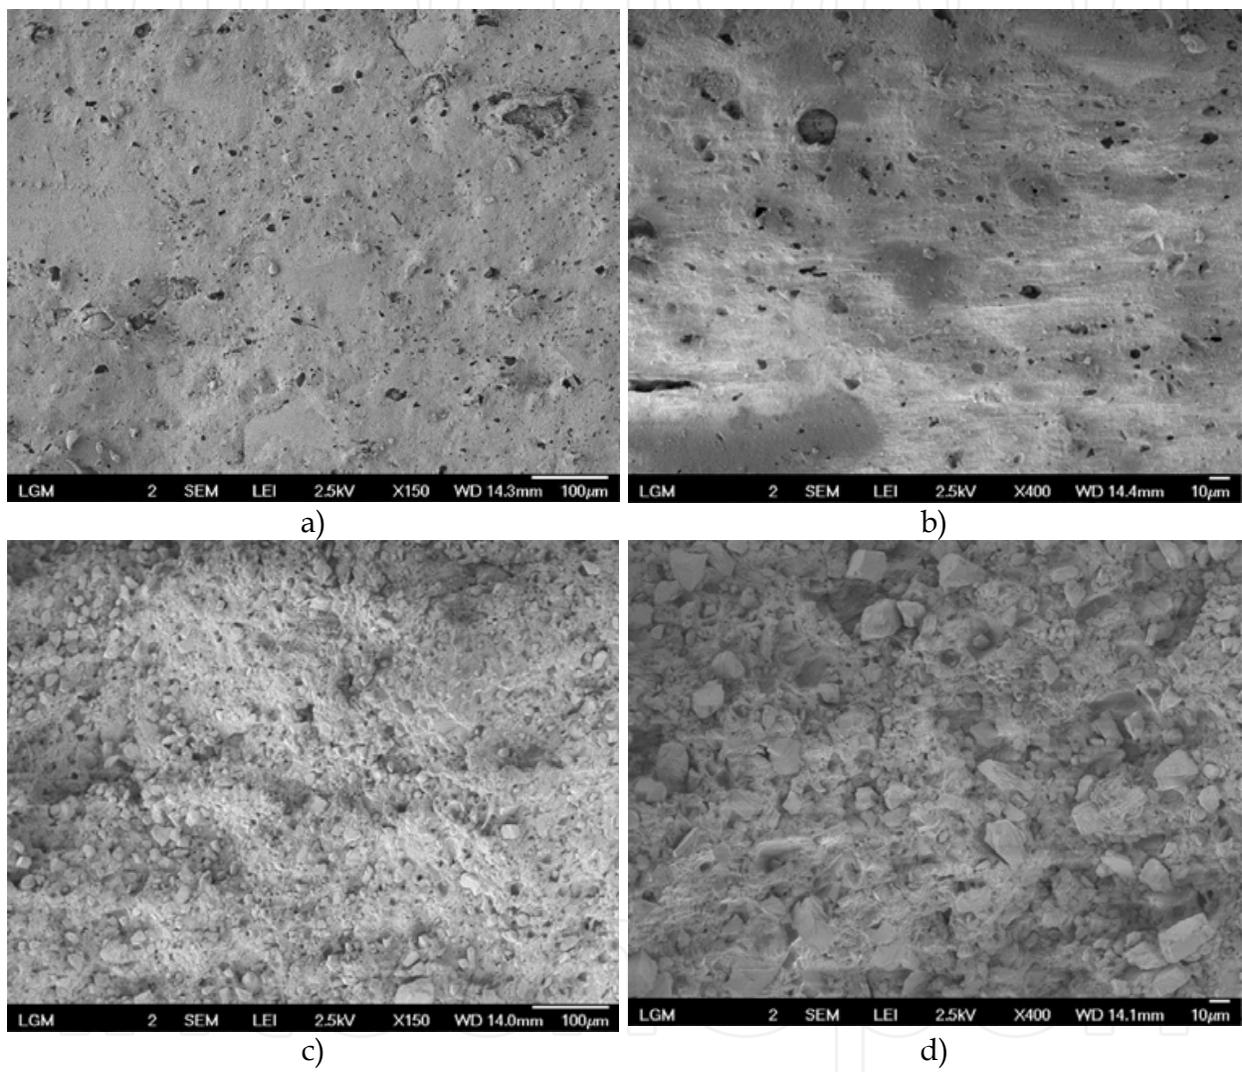
Figure 10 a) and b) indicates the presence of decohesion in the virgin specimen. Crack tends to initiate from pre-existing flaws. In this case inclusions in the material, causes decohesion (Saintier et al., 2006; Oshima et al., 2007). Decohesion causes crack to propagate much faster and speeds up the crack growth under fatigue loading. Decohesion is predominant in SiO₂ and CaCO₃ based materials. Since the rubber jounce bumper is made out of 39.8 % CaCO₃ and there were traces of aluminium found in the EDS analysis, it explains the formation of decohesions which results poor build in quality of the jounce bumper. Figure 10 c) and d) indicates that the fatigue failure occurred at high strains. This is due to the fact that major cracks throughout and area restrains the formation of microvoids and microcracks in that same area (Wang et al., 2002).

Fig. 10. Control Specimen a) x 150 & b) x 400. Failed Specimen c) x 150 & d) x 400
